**Designated Substances and
 Hazardous Materials Assessment,
 Highway 401, Planning
 Preliminary Design and Class
 Environmental Assessment, City
 of Brockville (G.W.P. 4003-19-00)**

Final Report

April 26, 2021

Stantec Consulting Ltd.
 18-15 Cedar Point Drive
 Barrie ON L4N 5R7

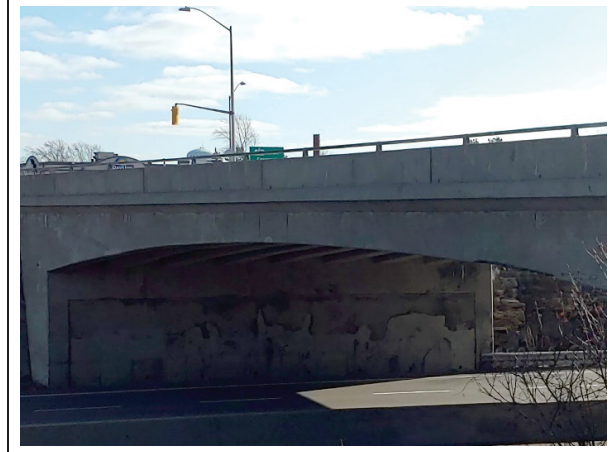
Photo 1: Highway 401/Stewart Boulevard Interchange (Site 16-121) in the City of Brockville, Ontario.

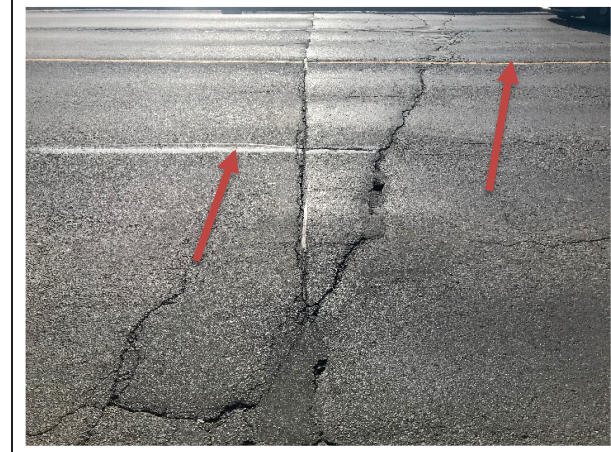
Photo 2: Potentially lead containing white and yellow coloured paint at Highway 401/Stewart Boulevard Interchange (Site 16-121).

Work that may disturb any lead-containing materials should follow the recommendations provided in the documents entitled

- *Environmental Abatement Council of Ontario (EACO) Lead Guideline for Construction, Maintenance or Repair*, dated October 2014
- *Ministry of Labour (MOL) Lead Guideline for Construction, Renovation Maintenance or Repair*, issued October 2014

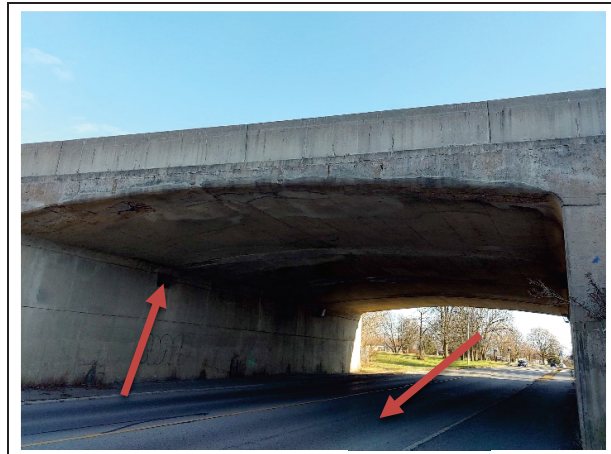
Equipment suspected to be mercury-containing was observed on site 16-123. Four high intensity light were observed on the under pass. Mercury may be present in paints and adhesives.

Four high intensity streetlights suspected to contain PCBs were observed at Site 16-123 Ormond Street Overpass.

Photo 3: Lighting at Highway 401/Ormond Street Overpass (Site 16-123) suspected to contain PCB ballasts and asphalt suspected to be asbestos-containing.

Fluorescent lamp ballasts that may contain PCBs can be managed in place, where these items are operating and in good condition.

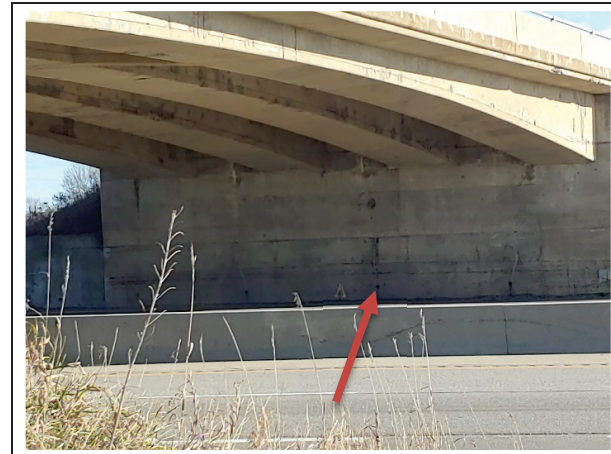
The condition of these materials is unknown as there was no access (refer to **Appendix D**). These materials were inaccessible and could not be sampled due to the high-speed traffic in the area. As these materials are known to have been manufactured with asbestos, they should be presumed to be asbestos containing unless proven otherwise by laboratory analysis.

Photo 4: Presumed asbestos-containing drain pipes at Highway 401/North Augusta Road Interchange (Site 16-124).

Based on the visual assessment, the locations of PACMs are provided in **Appendix D**. Stantec recommends the following with regards to meeting the requirements of O. Reg. 278/05:
