APPENDIX M: EROSION AND SEDIMENT OVERVIEW RISK ASSESSMENT

File: 165001160 Date: May 19, 2022

Reference: Highway 401 Planning, Preliminary Design, and Class Environmental Assessment (Class EA) Study, City of Brockville - Erosion and Sediment Overview Risk Assessment - GWP 4003-19-00

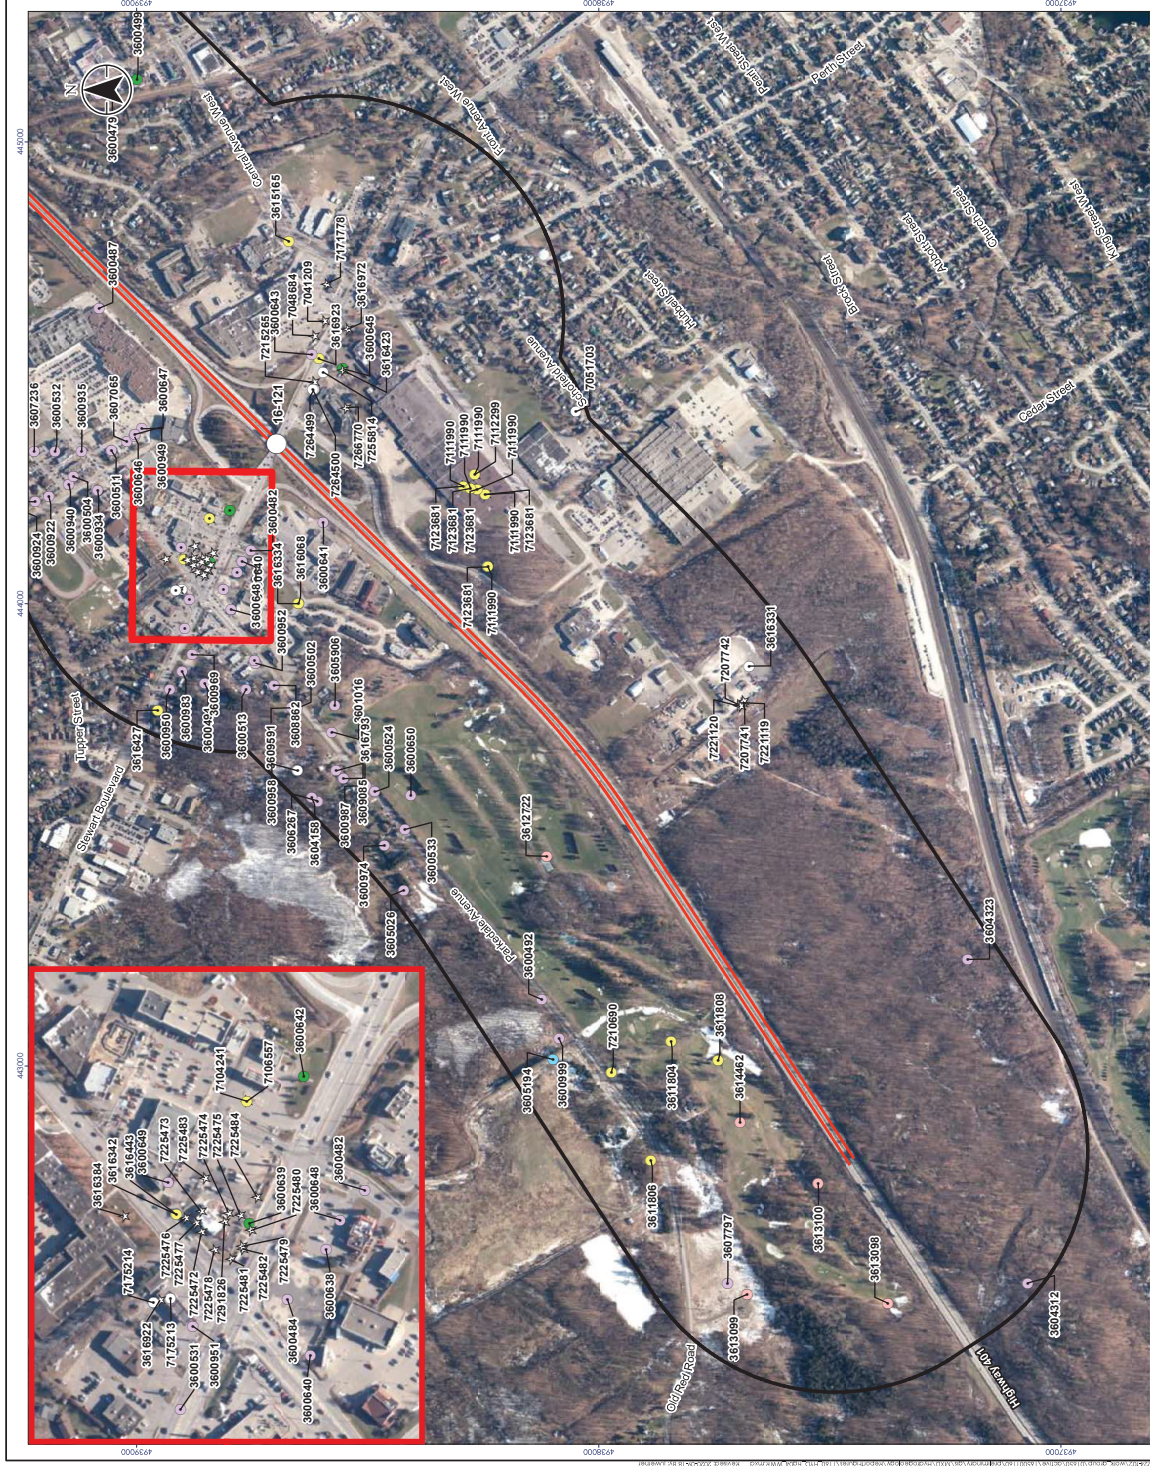
Figure No.: 2a

The *Groundwater Assessment – Highway 401 Rehabilitation / Replacement of Various Structures and Pavement Reconstruction, City of Brockville* (Stantec, 2020) was reviewed to identify sensitive groundwater and surface water features within the proximity of study area. Using MECP records, it was confirmed that 193 Water Well Records were within 500 m of the project limits. These well include public supply wells, commercial supply well, abandoned wells, and potential private supply wells, as shown on Figure 2, attached.

Title: MECP Water Well Records (within 500 m)

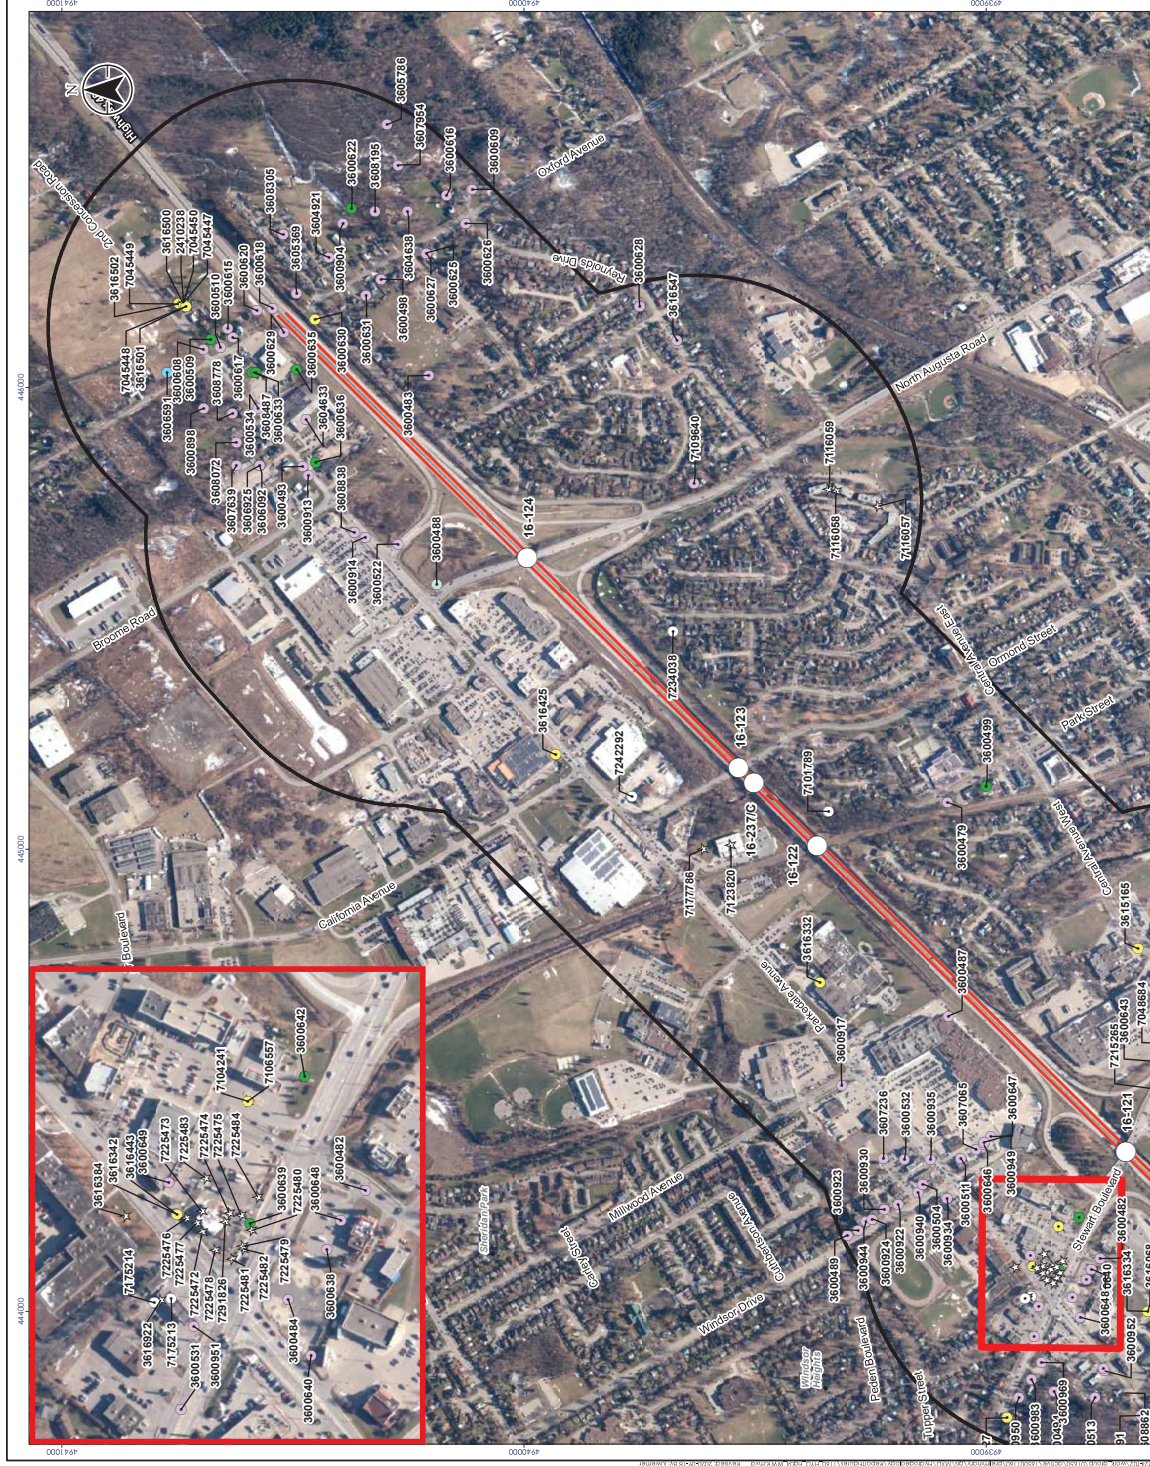
Figure No.: 2b

Title: MECP Water Well Records (within 500 m)

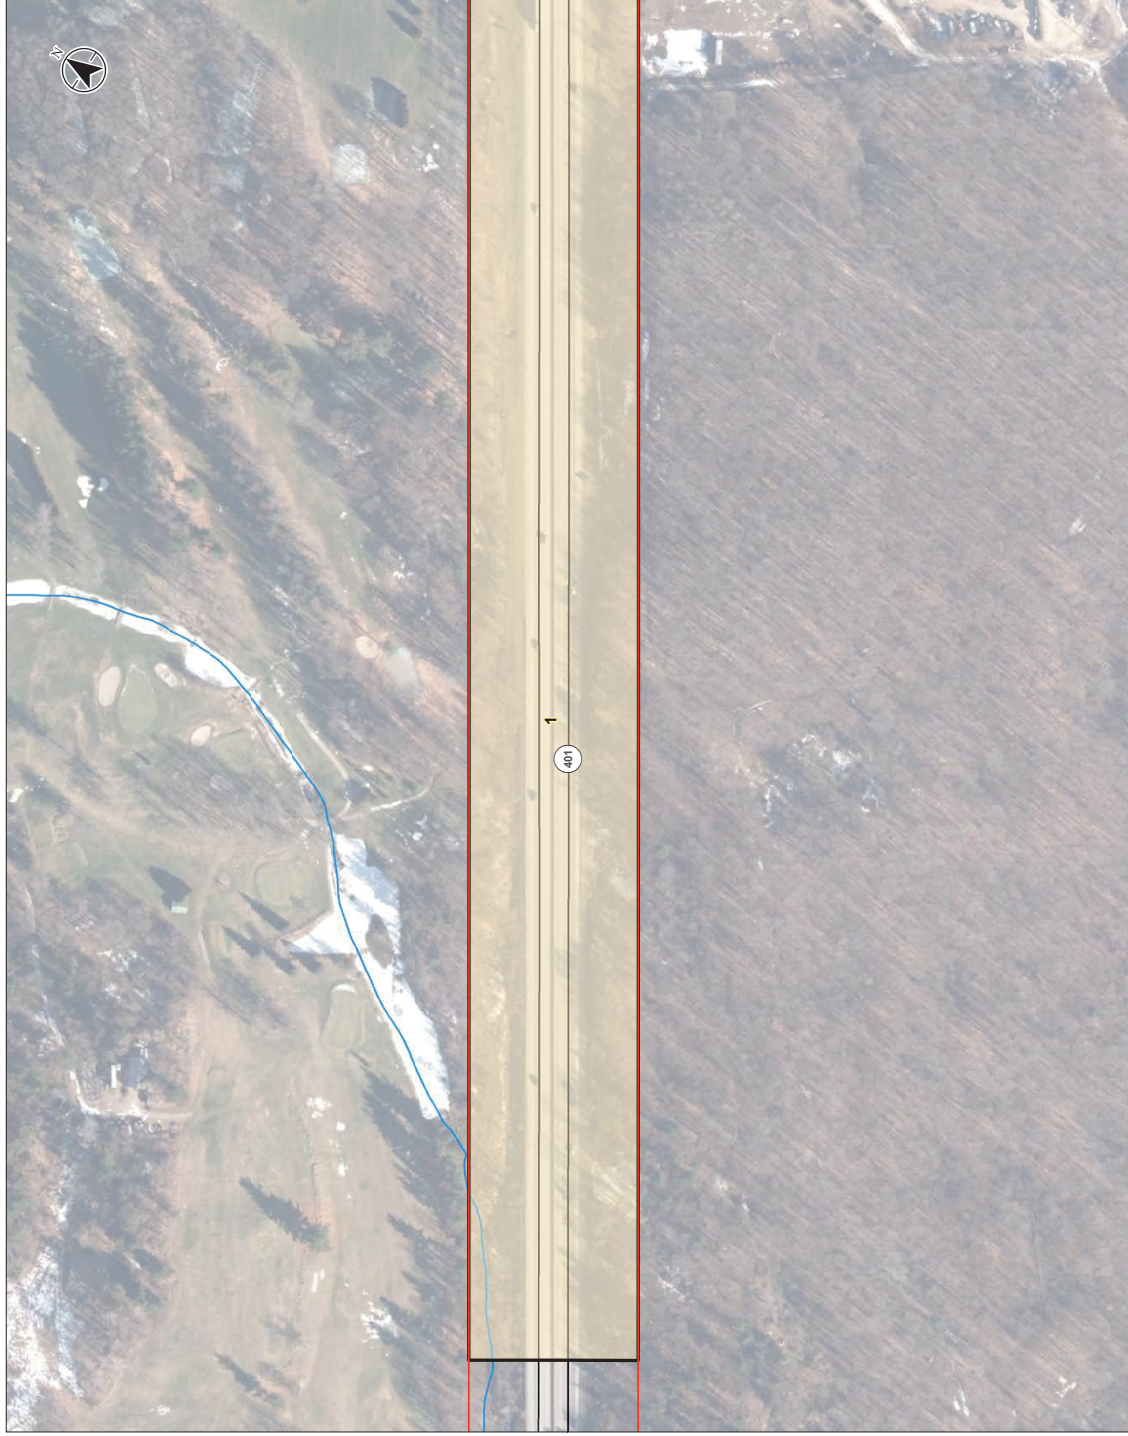
Figure No.
3-a

An ESORA was performed for the study area to determine which Erosion and Sediment Control (ESC) approach is best suited for the anticipated construction works. To complete the assessment, the study area was divided into the evaluation polygons using surficial geology data. These areas were each assigned a Soil Erodibility Rating based on soil type, and an Erosion Potential Rating which combined soil type as well as the proposed slope gradient and proposed slope length. Figure 3, attached, illustrates the evaluated areas and the associated Soil Erodibility Ratings.

The site soils are sand to silty-sand loams and have a medium to high erosion potential. Generally, sandy soils were assigned a medium soil erodibility rating and silty-sand was assigned a high soil erodibility rating, following Table 5.1 – Hierarchy of Soil Erodibility in the *Environmental Guide for Erosion and Sediment Control During Construction of Highway Projects* (Ministry of Transportation, 2015).

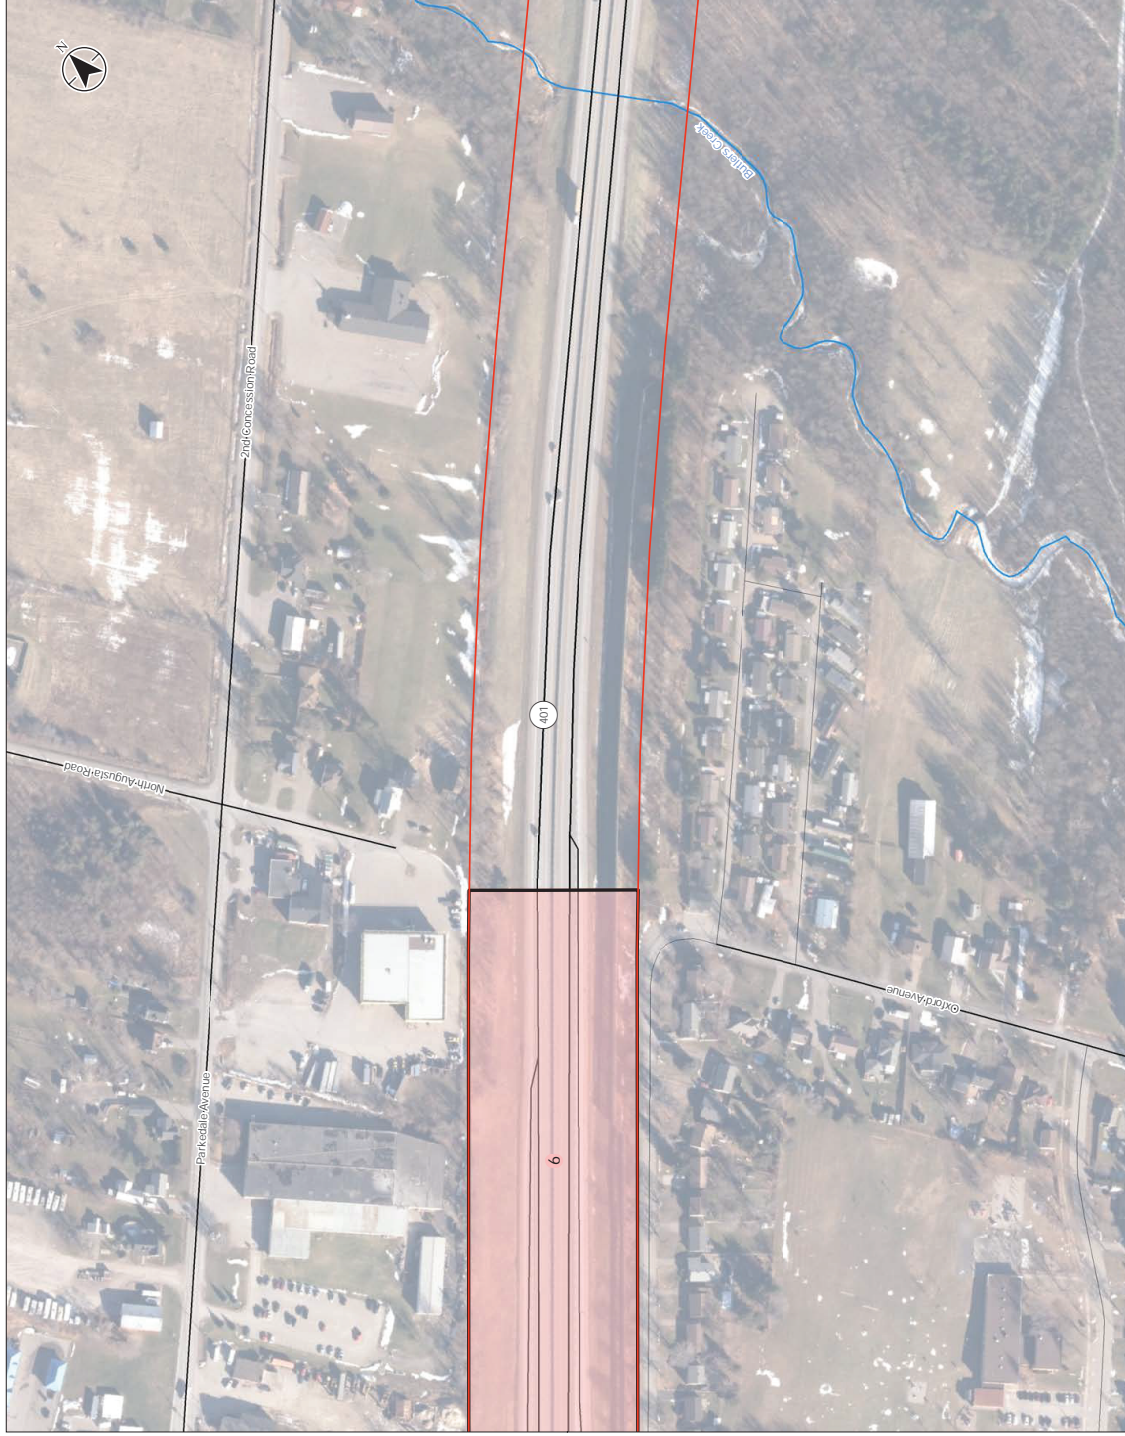
6

Title
 Erosion and Sediment Overview Risk Assessment

- Legend
- MTO ROW
 - Study Area
 - Highway
 - Major Road
 - Minor Road
 - Watercourse (Permanent)
 - Erodibility - High

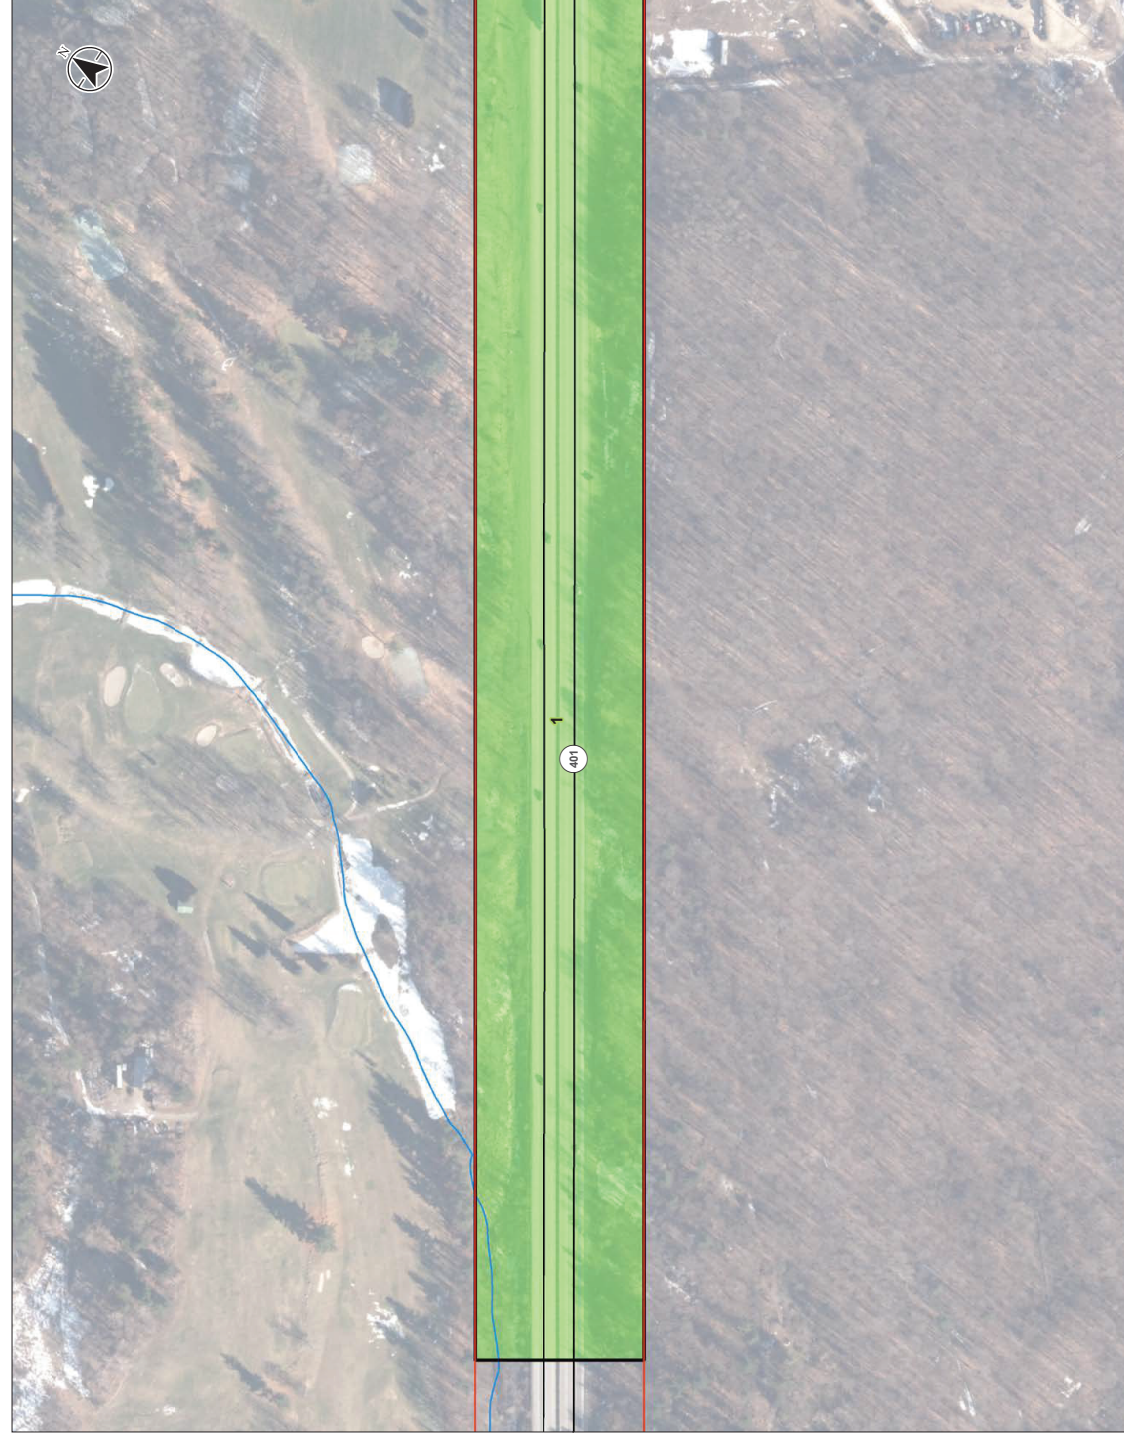
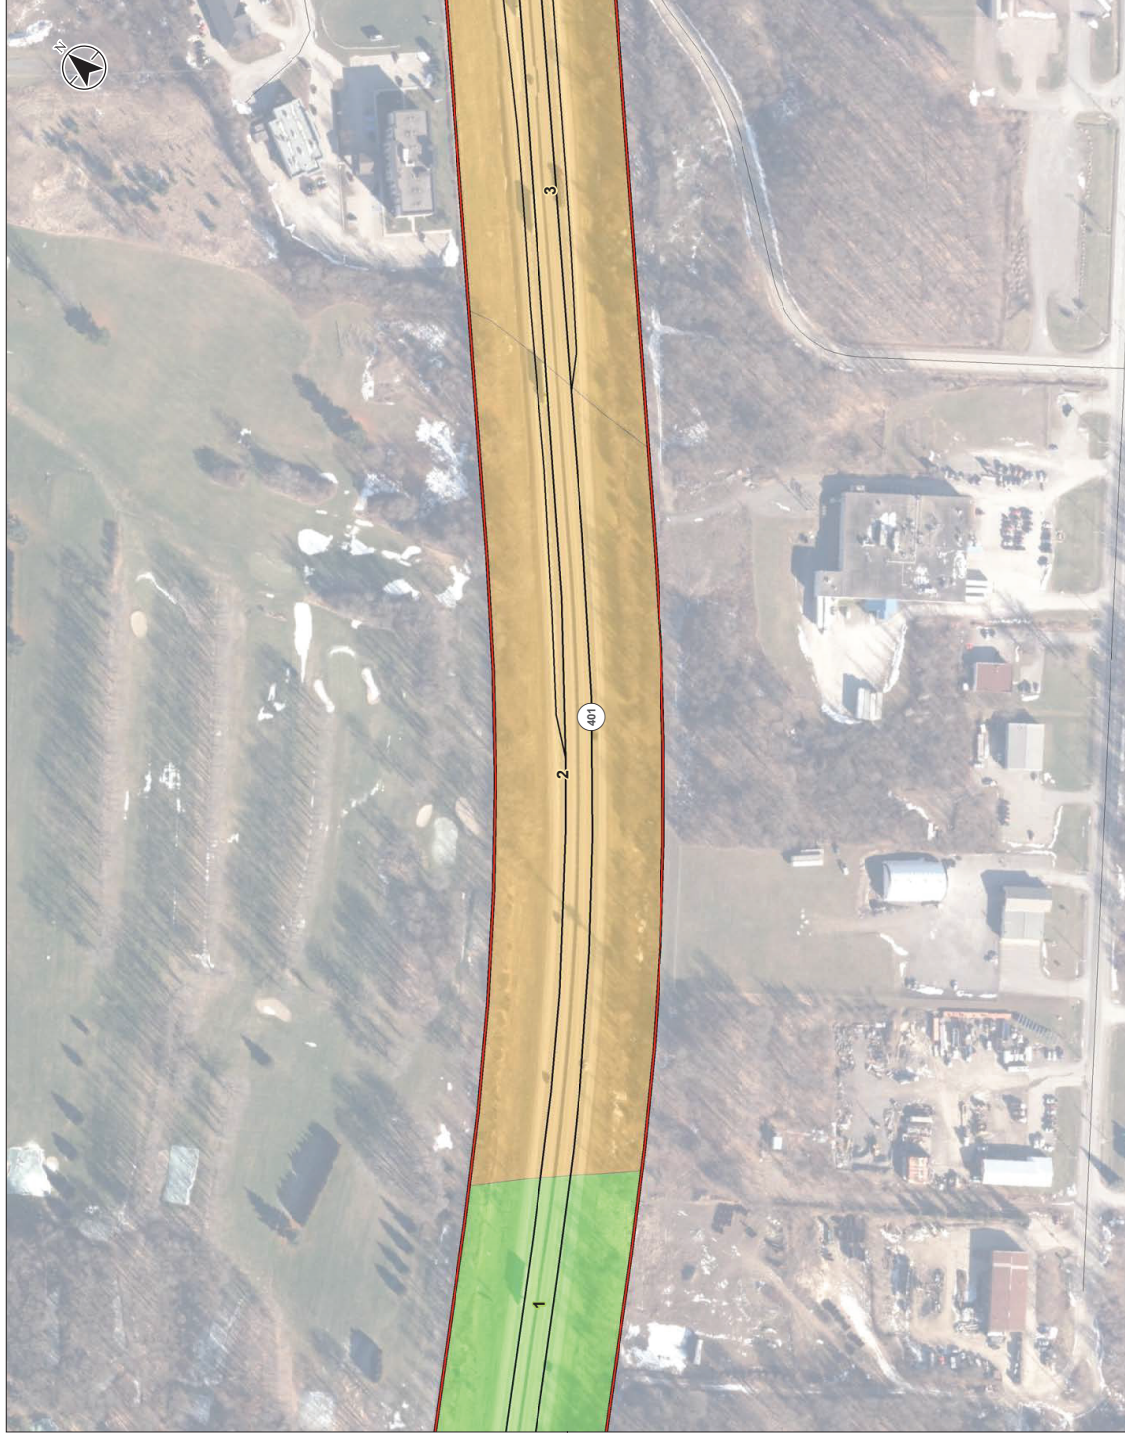
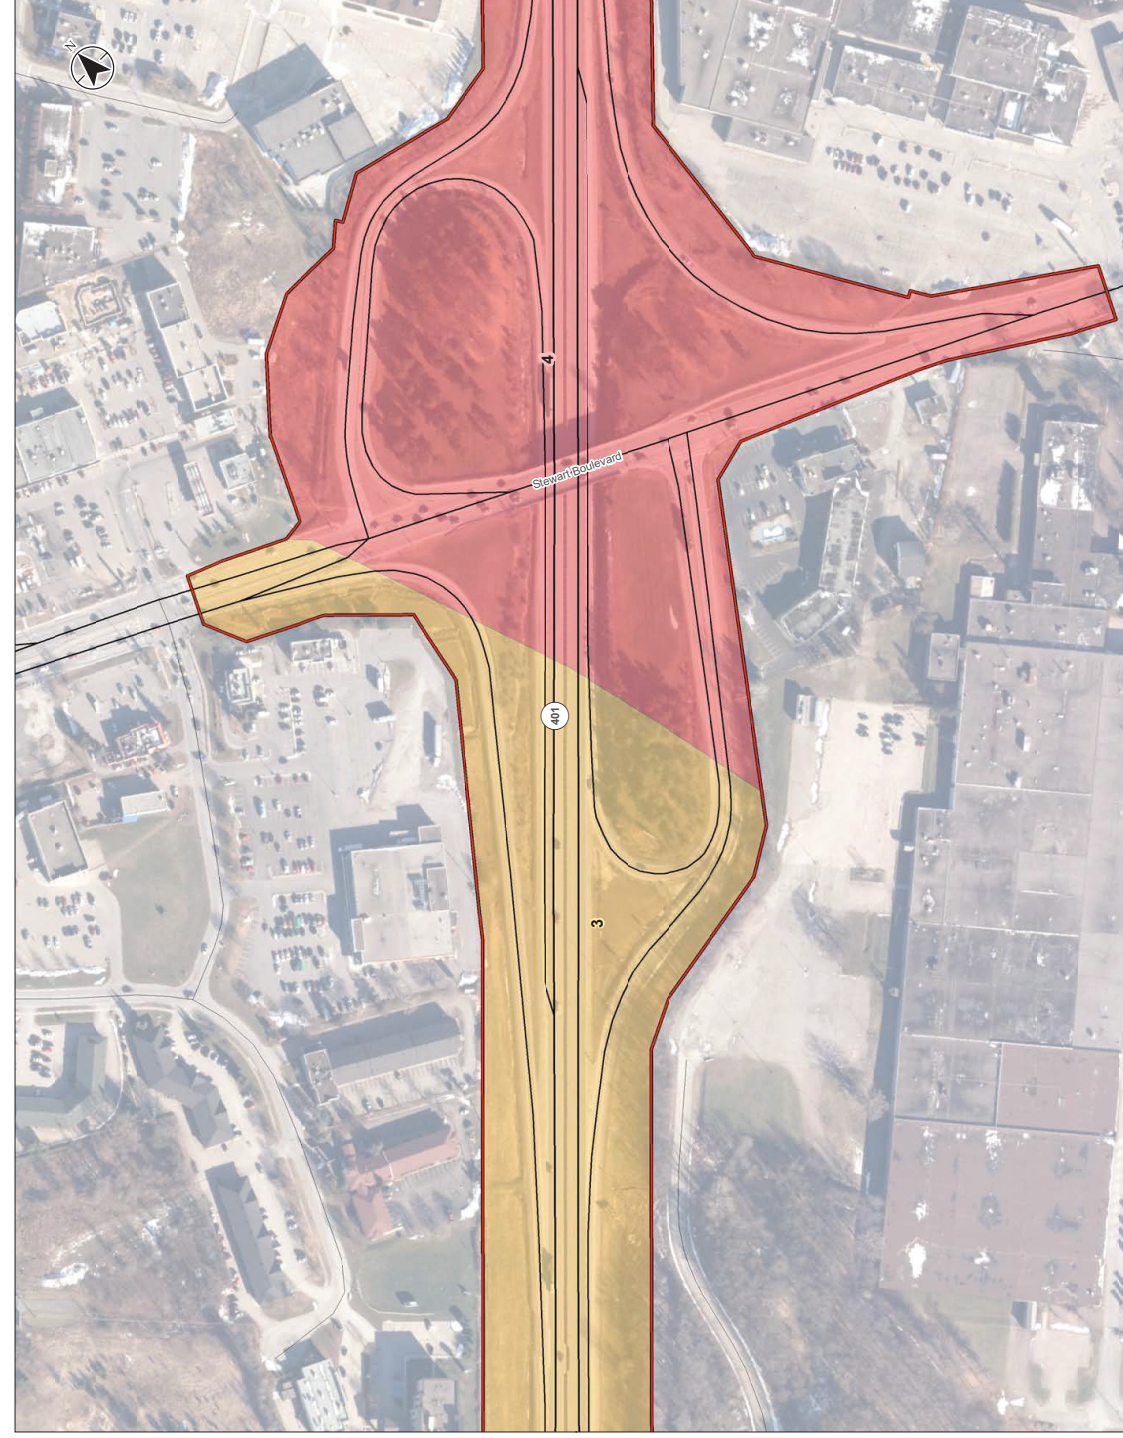
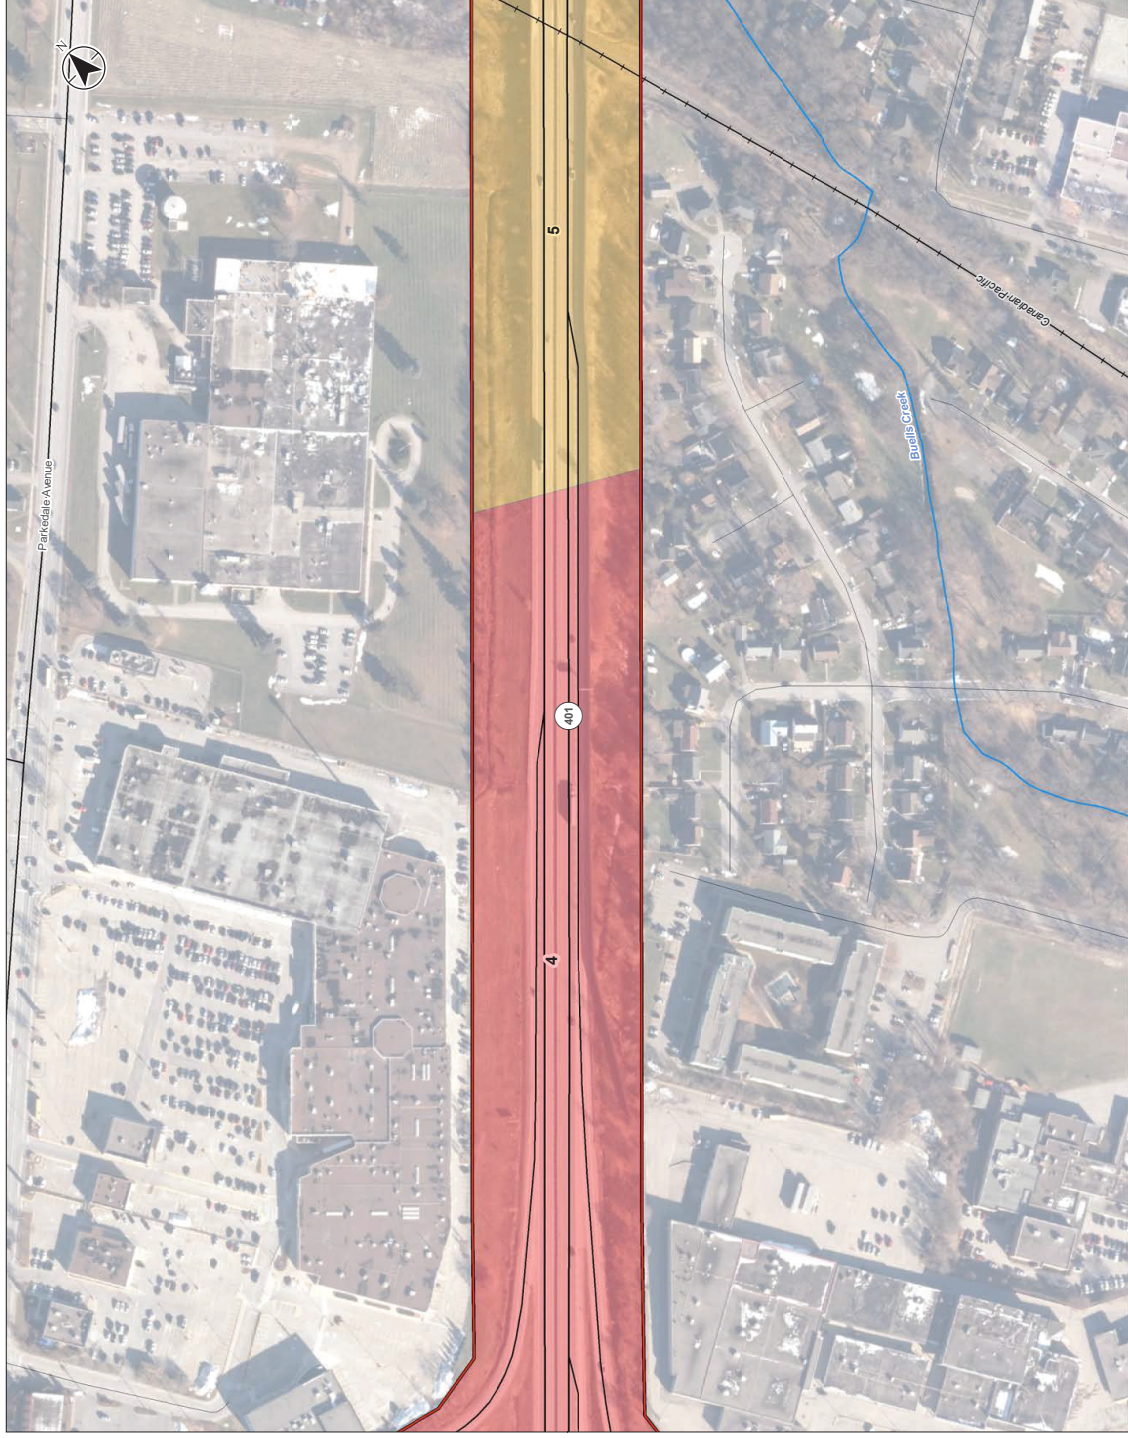
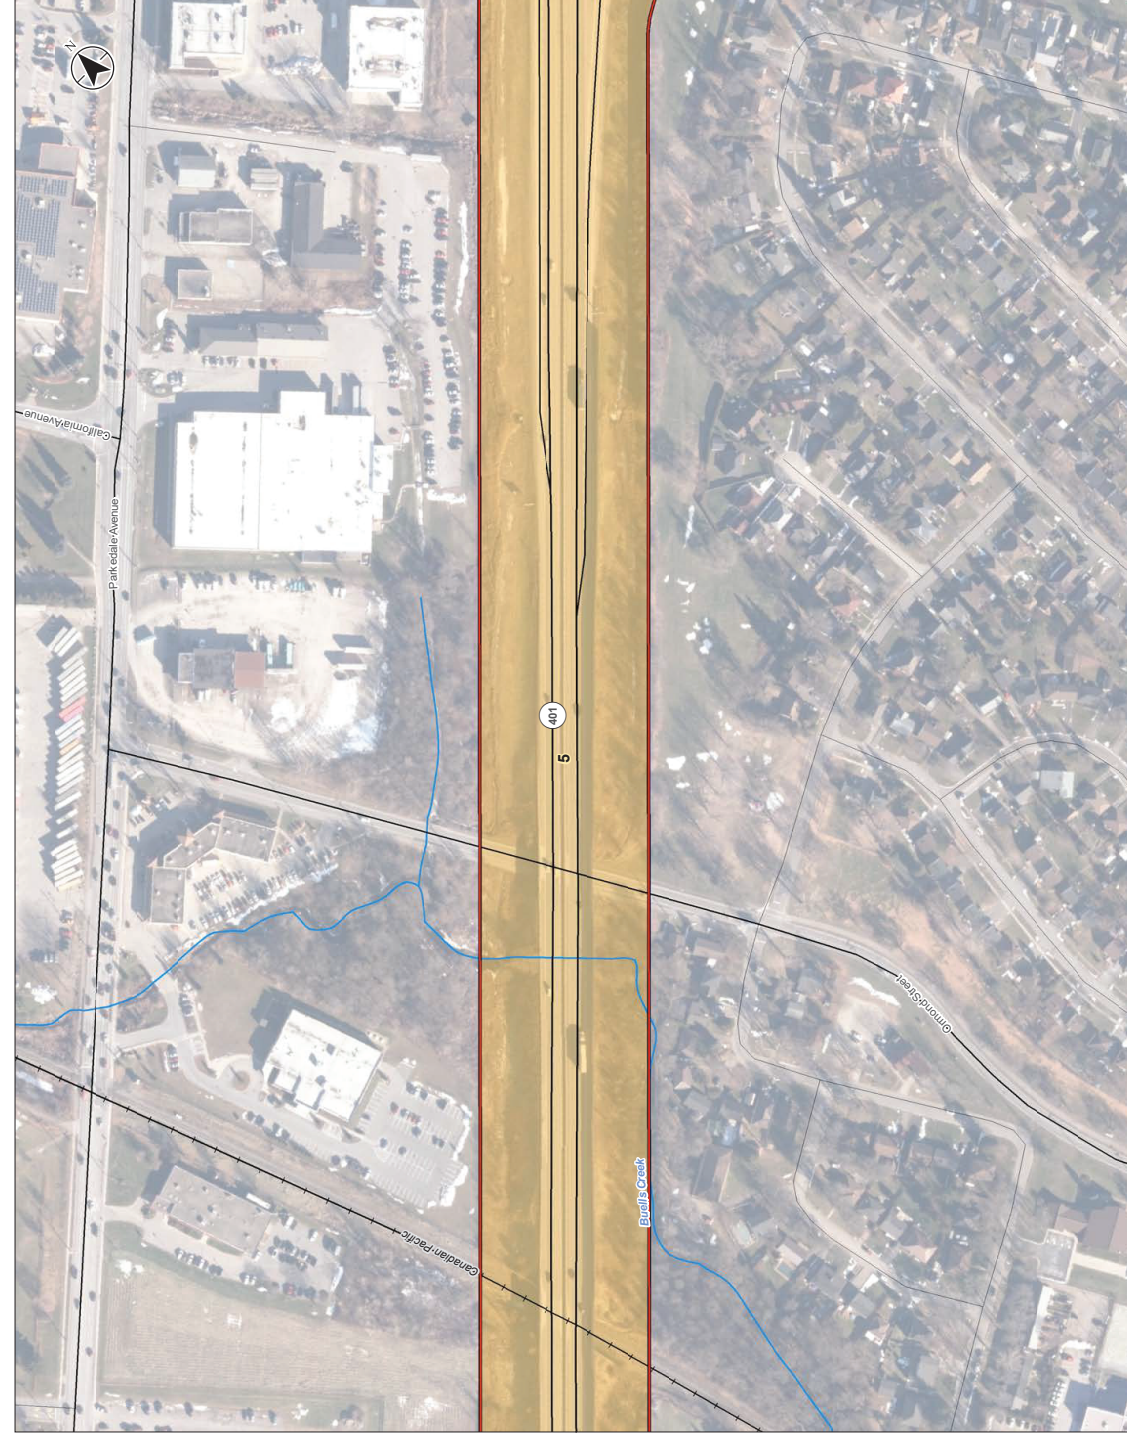
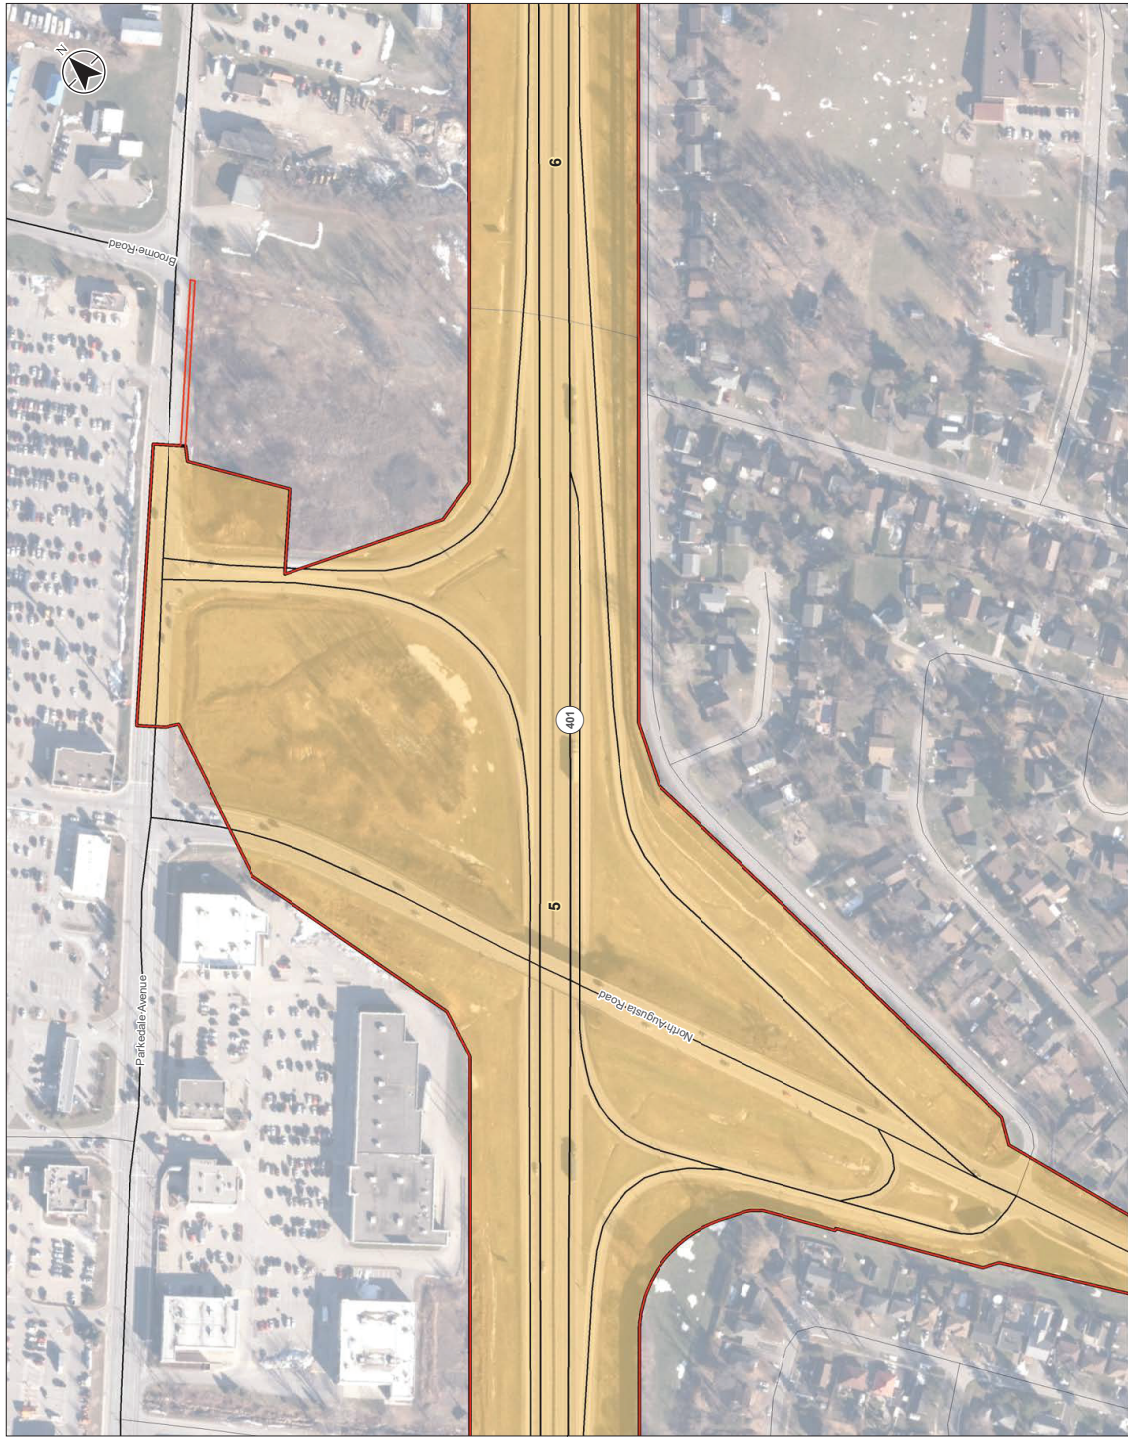
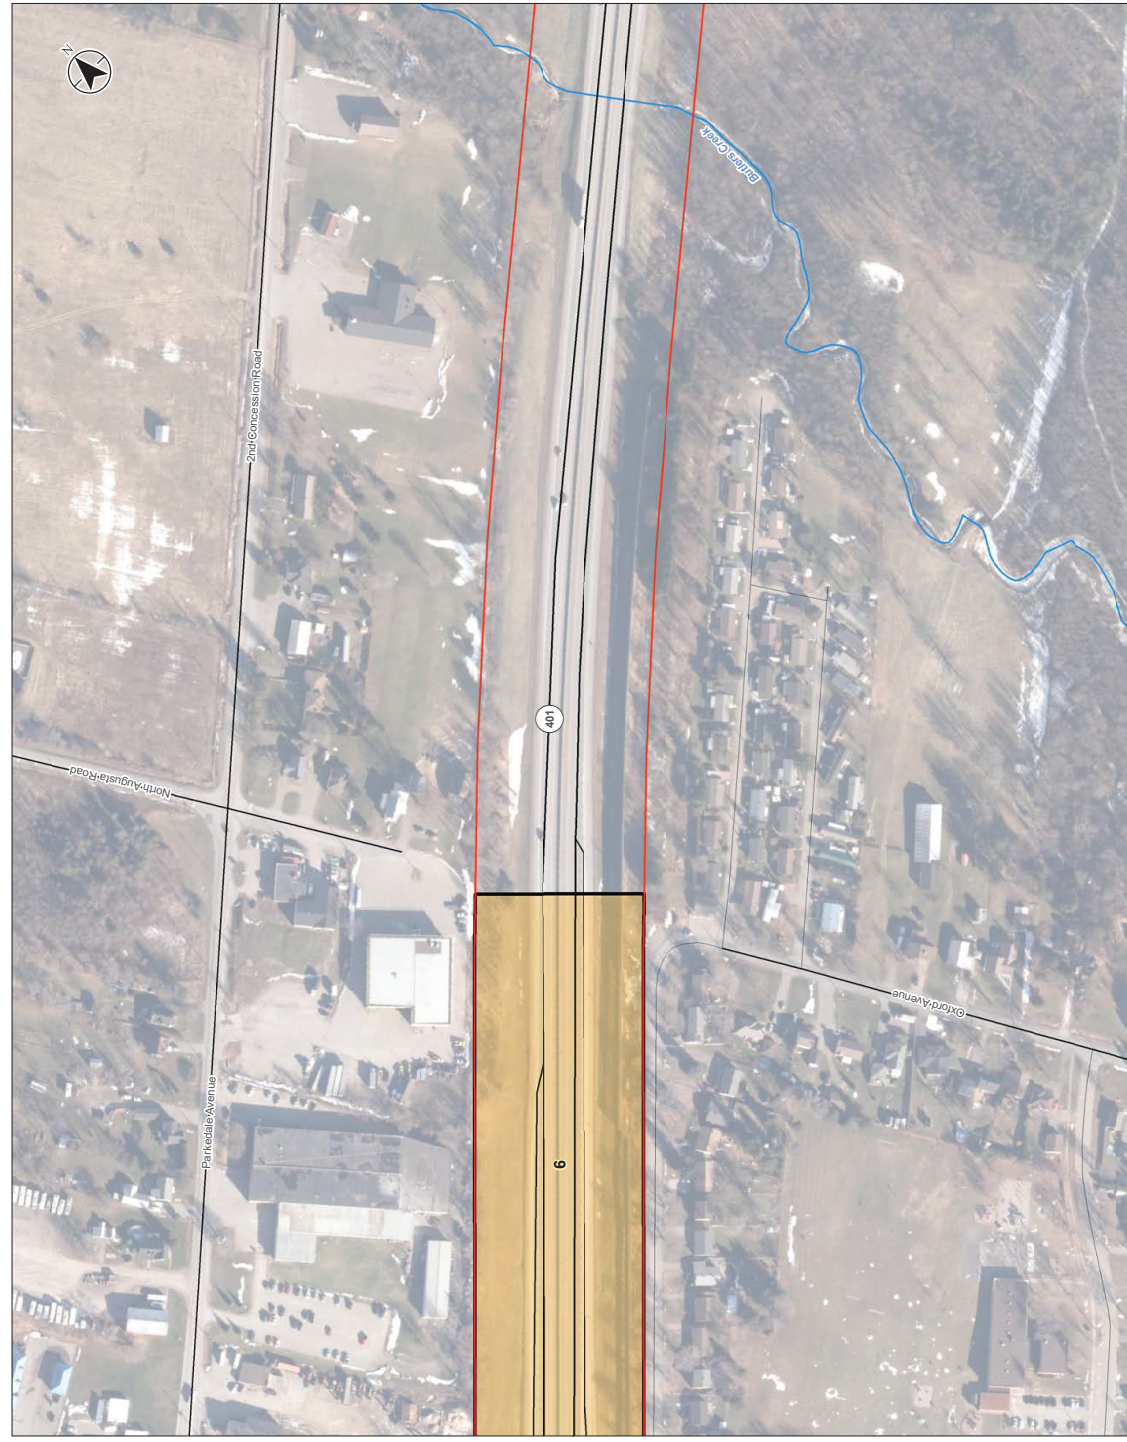
The three ratings (Soil Erodibility, Erosion Potential and Environmental Consequence) were all considered to assign the cumulative Erosion and Sediment Risk rating to each evaluated area. Results of the completed evaluation, including rationale for the assigned Erosion Potential Rating, Environmental Risk Rating and cumulative Erosion and Sediment Risk rating are shown in Table 1 below. The attached Figure 4 shows the Erosion Risk rating for each evaluated polygon.

Title
Overall Erosion and Sediment Risk

The majority of evaluated areas had an overall medium-high erosion and sediment risk rating based on medium erodibility soils and moderately sensitive environmental features. An erosion and sediment control plan will be developed for all construction zones in future design phases to mitigate the erosion and sediment risk and minimize impacts downstream.
