TRANSPORTATION ENVIRONMENTAL STUDY REPORT

Highway 401 Planning, Preliminary Design and Class Environmental Assessment, Brockville, GWP 4003-19-00

APPENDIX C:
FISH AND FISH HABITAT EXISTING CONDITIONS AND PRELIMINARY IMPACT ASSESSMENT
REPORT

**Fish and Fish Habitat Existing
Conditions and Preliminary
Impact Assessment Report**

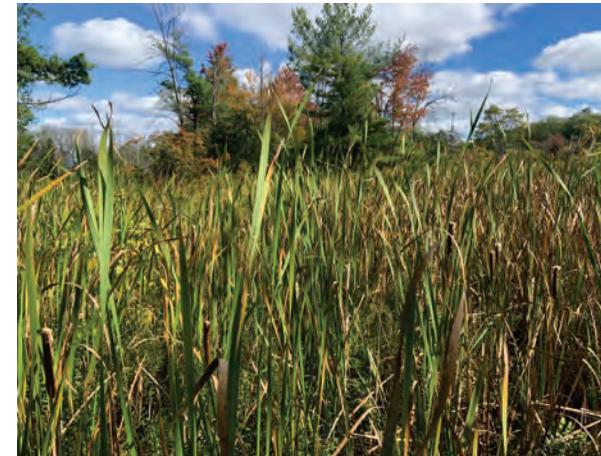
Photo 1: Tributary to Grants Creek; Highway 401 Westbound, south of the tributary facing north (September 28, 2021)

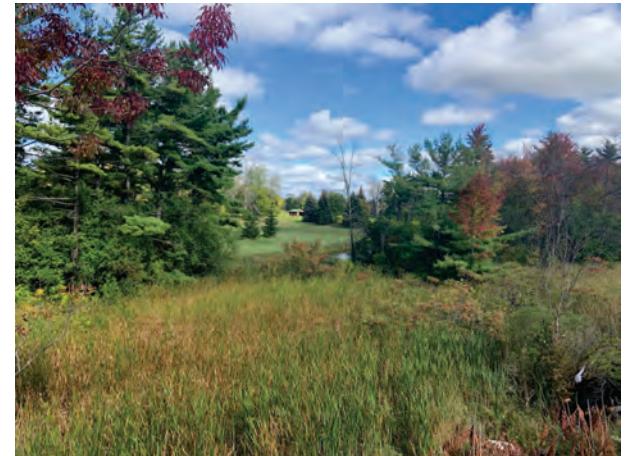
Photo 2: Tributary to Grants Creek; Highway 401 Westbound, facing north toward the tributary (before it enters the Highway 401 ROW) (September 28, 2021)

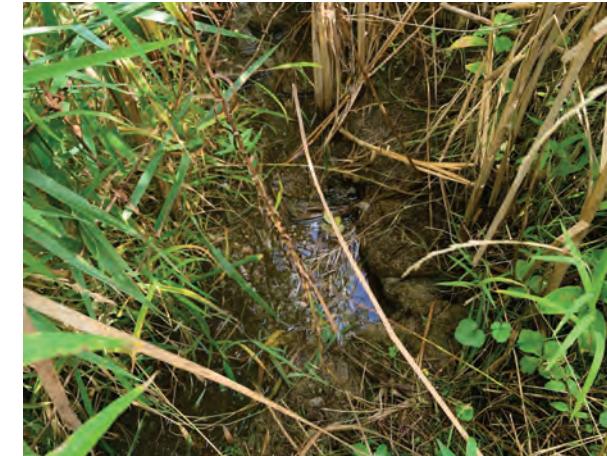
Photo 3: Tributary to Grants Creek; Highway 401 Westbound, within the Highway 401 ROW (September 28, 2021)

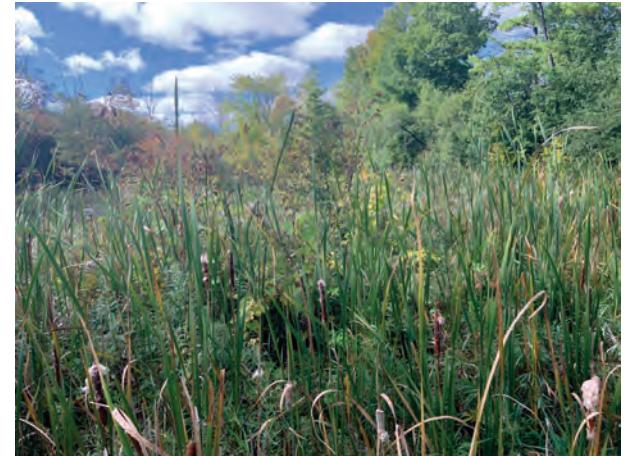
Photo 4: Tributary to Grants Creek; Highway 401 Westbound, within the Highway 401 ROW, facing southwest (downstream) (September 28, 2021)

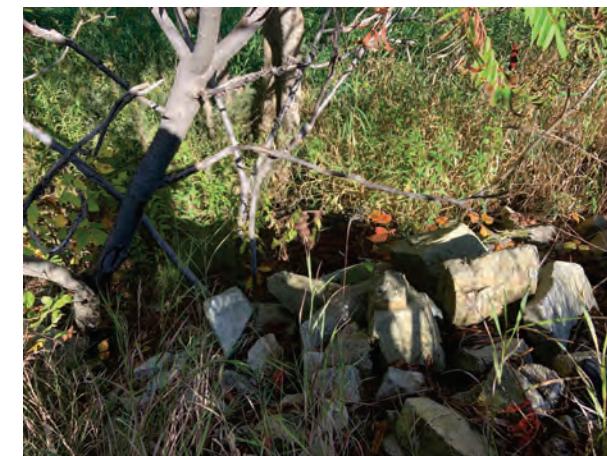
Photo 5: Culvert C1; Station 19+794 (Elizabethtown); Highway 401 Westbound, facing northwest (downstream) (September 28, 2021)

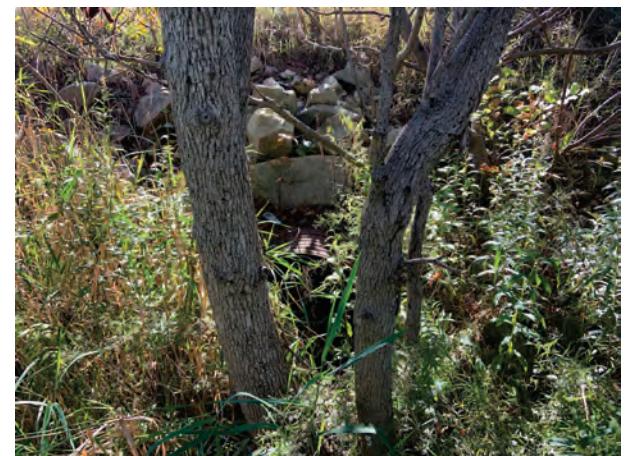
Photo 6: Culvert C1; Station 19+794 (Elizabethtown); Highway 401 Westbound, culvert outlet facing south (upstream) (September 28, 2021)

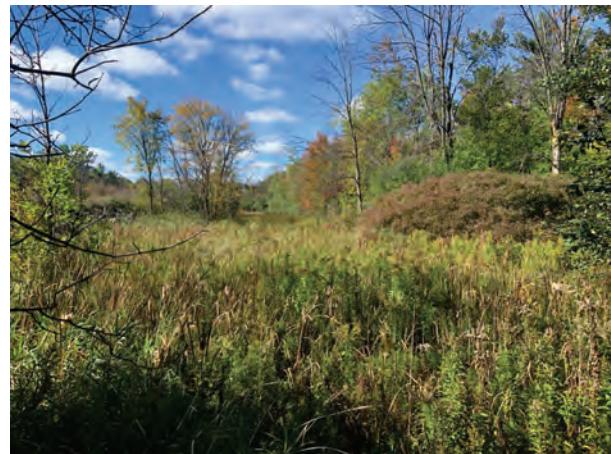
Photo 7: Culvert C1; Station 19+794 (Elizabethtown); Highway 401 West-bound, facing west (downstream) (September 28, 2021)

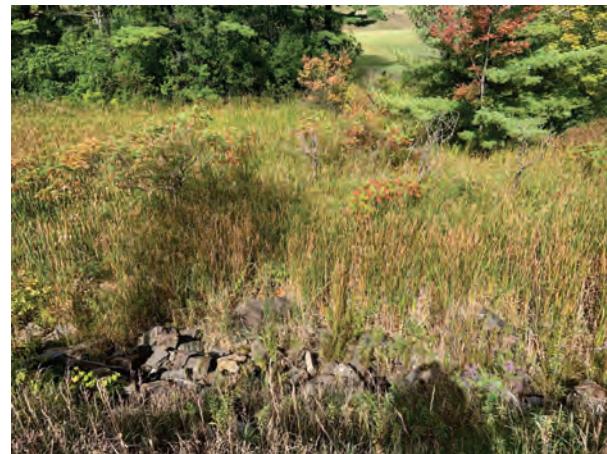
Photo 8: Culvert C1; Station 19+794 (Elizabethtown); Highway 401 West-bound, facing northwest (downstream) toward the confluence with the Tributary to Grants Creek (September 28, 2021)

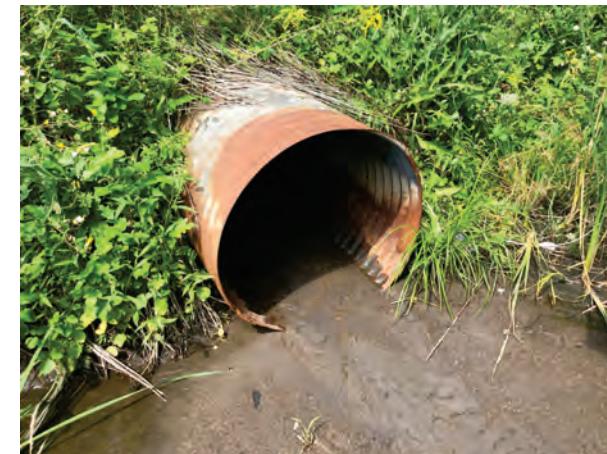
Photo 13: Culvert C2; Station 20+080 (Elizabethtown); Highway 401 East-bound, facing north (August 10, 2020)

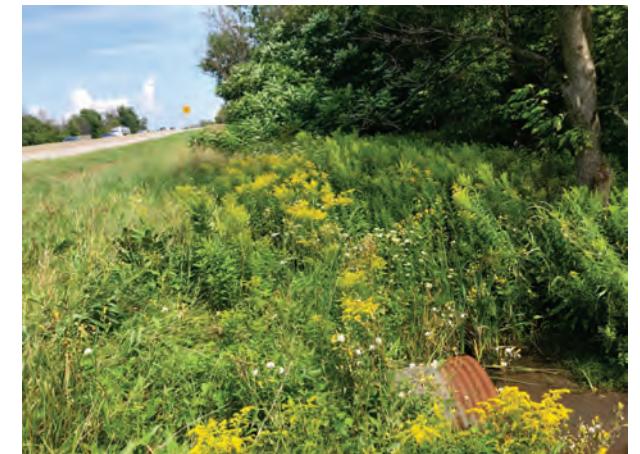
Photo 14: Culvert C2; Station 20+080 (Elizabethtown); Highway 401 East-bound, facing east (August 10, 2020)

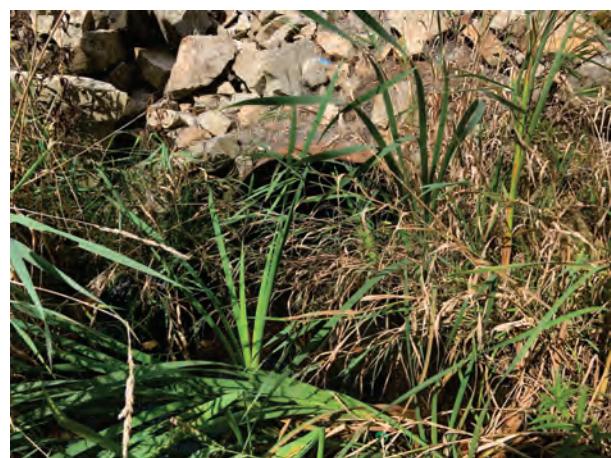
Photo 9: Culvert C1; Station 19+794 (Elizabethtown); Highway 401 East-bound, culvert inlet facing north (downstream) (September 28, 2021)

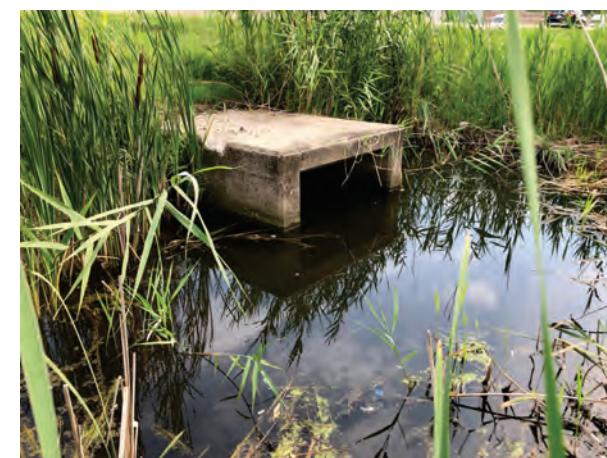
Photo 15: Culvert C4; Station 21+899 (Elizabethtown); Highway 401 West-bound, culvert outlet facing southwest (upstream) (August 10, 2020)

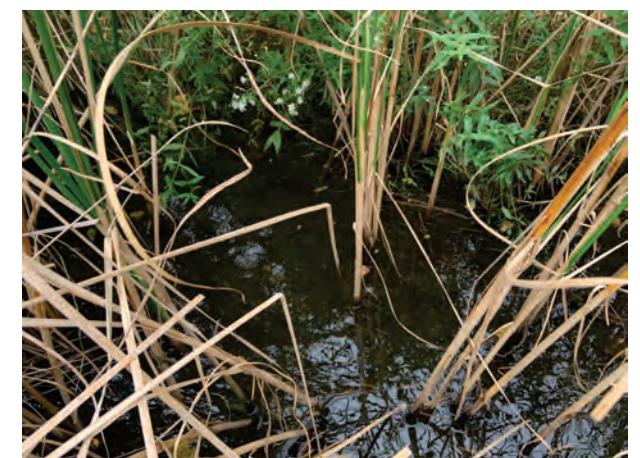
Photo 16: Culvert C4; Station 21+899 (Elizabethtown); Highway 401 West-bound, facing northeast (downstream) (September 28, 2021)

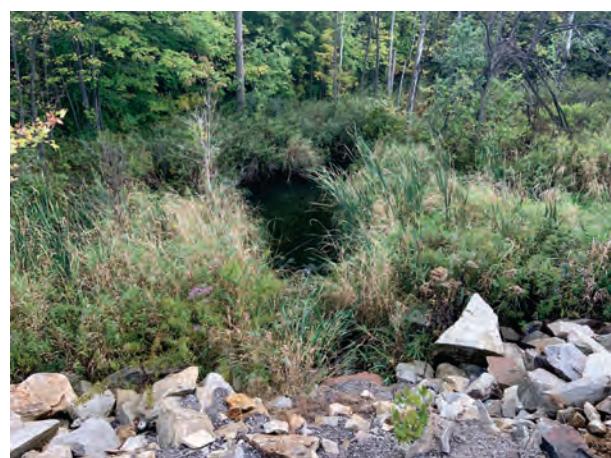
Photo 11: Culvert C1; Station 19+794 (Elizabethtown); Highway 401 East-bound, facing south (upstream) (September 28, 2021)

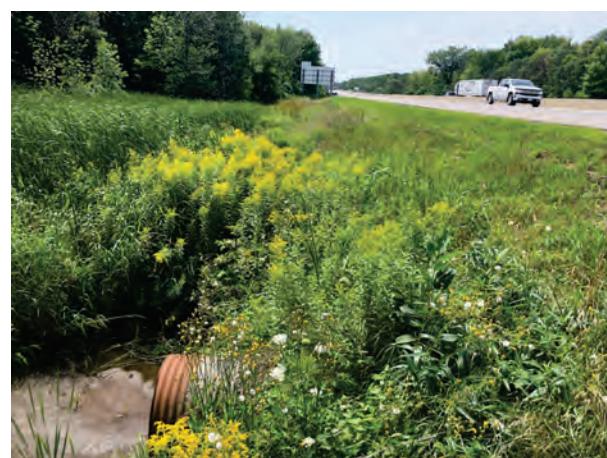
Photo 12: Culvert C2; Station 20+080 (Elizabethtown); Highway 401 East-bound, facing west (August 10, 2020)

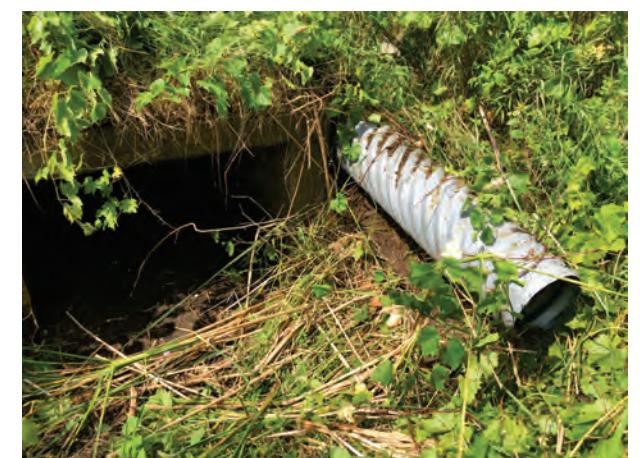
Photo 18: Culvert C4; Station 21+899 (Elizabethtown); Highway 401 East-bound, culvert inlet facing north (downstream) (August 10, 2020)

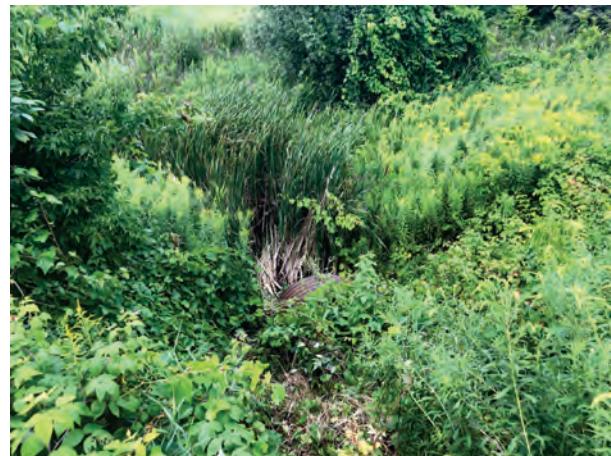
Photo 19: Culvert C5; Station 22+219 (Elizabethtown); Highway 401 Westbound, facing north (upstream) (August 10, 2020)

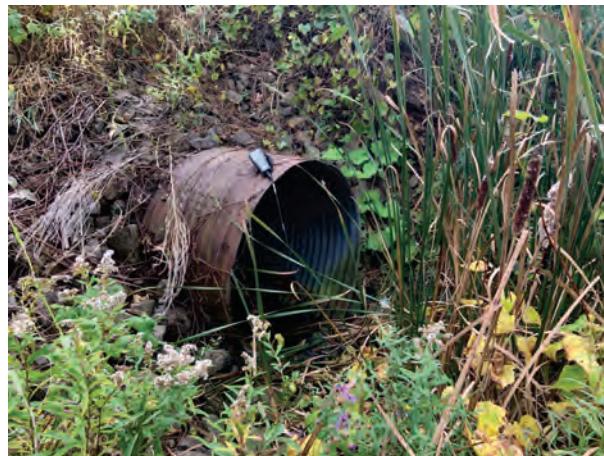
Photo 20: Culvert C5; Station 22+219 (Elizabethtown); Highway 401 Westbound, culvert inlet facing south (downstream) (September 28, 2021)

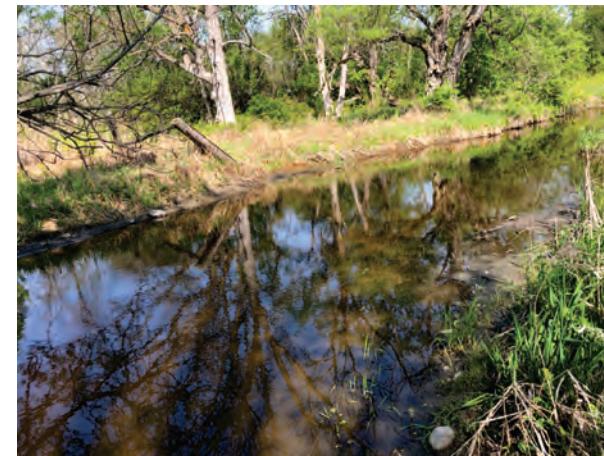
Photo 25: Culvert C6 (MTO Site 16X-0237/C0); Station 22+503 (Elizabethtown); Buells Creek, Highway 401 Westbound, facing north (upstream) (May 18, 2021)

Opportunities for habitat enhancement in the Study Area include repairs to the gabion baskets at Buells Creek (Culvert C6; MTO Site 16X-0237/C0) and other bank stabilization measures on the south side of Highway 401. The addition of instream structure would enhance habitat in Buells Creek on the north side of Highway 401. Seasonal barriers to fish passage (i.e., isolated pools) were observed in the tributary to Buells Creek (Culvert C7) but the pools provide summer refuge and should be maintained or replaced, as appropriate.

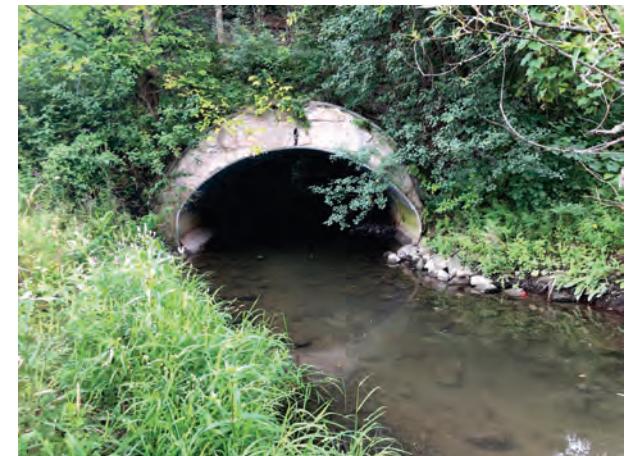
Photo 26: Culvert C6 (MTO Site 16X-0237/C0); Station 22+503 (Elizabethtown); Buells Creek, Highway 401 Westbound, culvert inlet facing southeast (downstream) (August 25, 2020)

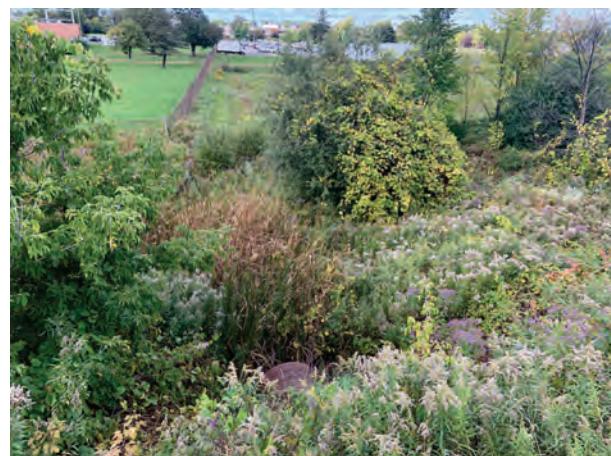
Photo 21: Culvert C5; Station 22+219 (Elizabethtown); Highway 401 Westbound, facing northwest (upstream) (September 28, 2021)

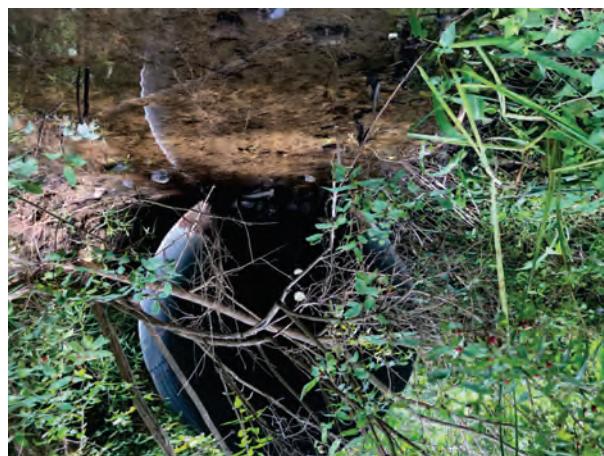
Photo 22: Culvert C5; Station 22+219 (Elizabethtown); Highway 401 Eastbound, culvert outlet facing northwest (upstream) (August 10, 2020)

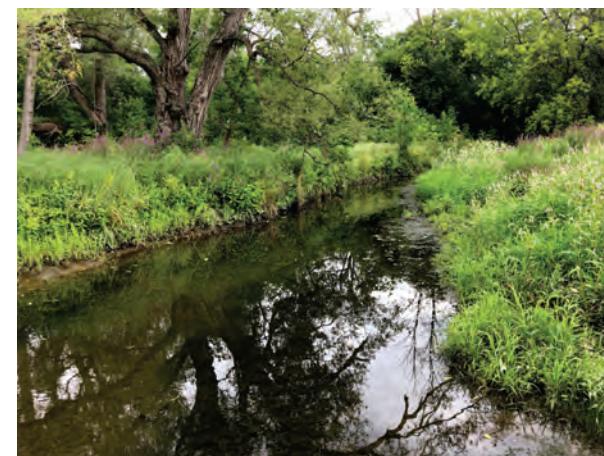
Photo 27: Culvert C6 (MTO Site 16X-0237/C0); Station 22+503 (Elizabethtown); Buells Creek, Highway 401 Westbound, facing north (upstream) (August 25, 2020)

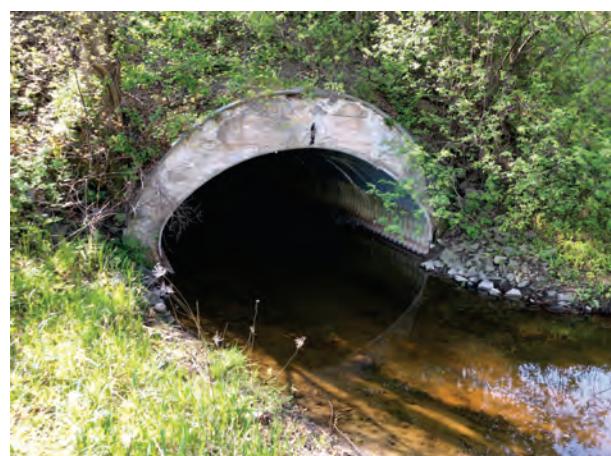
Photo 23: Culvert C6 (MTO Site 16X-0237/C0); Station 22+503 (Elizabethtown); Buells Creek, Highway 401 Westbound, culvert inlet facing southeast (downstream) (May 18, 2021)

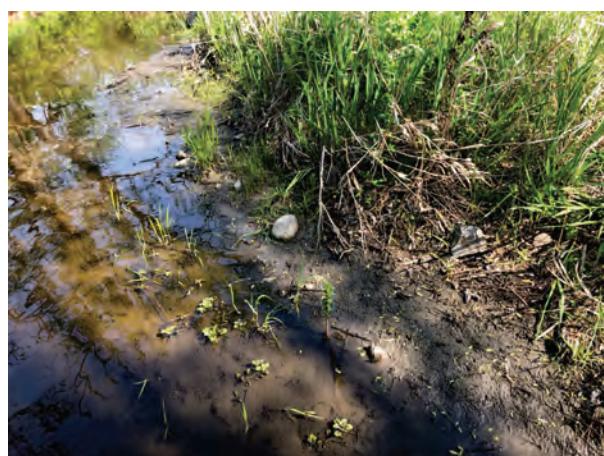
Photo 24: Culvert C6 (MTO Site 16X-0237/C0); Station 22+503 (Elizabethtown); Buells Creek, Highway 401 Westbound, facing the streambed (May 18, 2021)

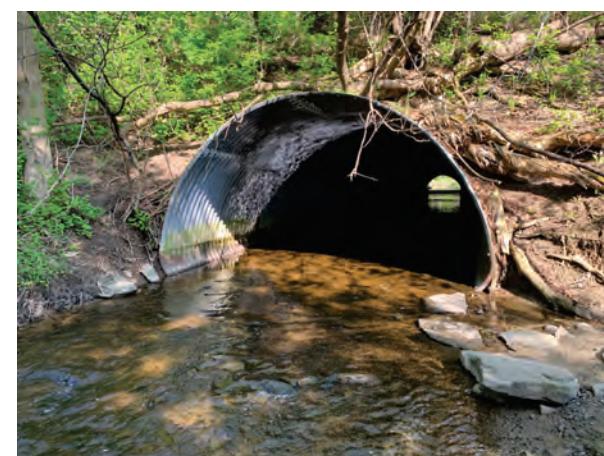
Photo 29: Culvert C6 (MTO Site 16X-0237/C0); Station 22+503 (Elizabethtown); Buells Creek, Highway 401 Eastbound, culvert outlet facing northwest (upstream) (May 18, 2021)

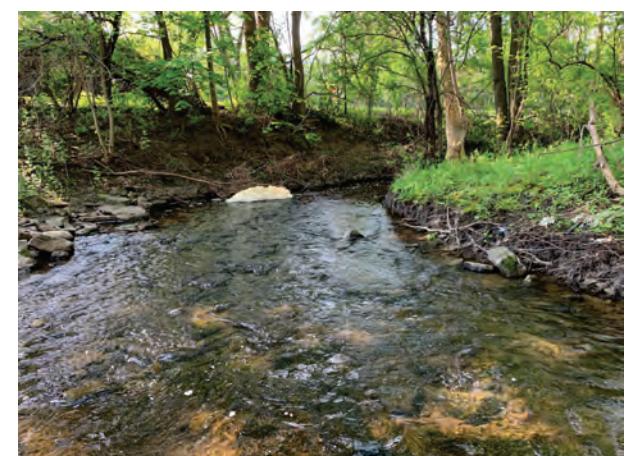
Photo 30: Culvert C6 (MTO Site 16X-0237/C0); Station 22+503 (Elizabethtown); Buells Creek, Highway 401 Eastbound, facing southeast (downstream) (May 18, 2021)

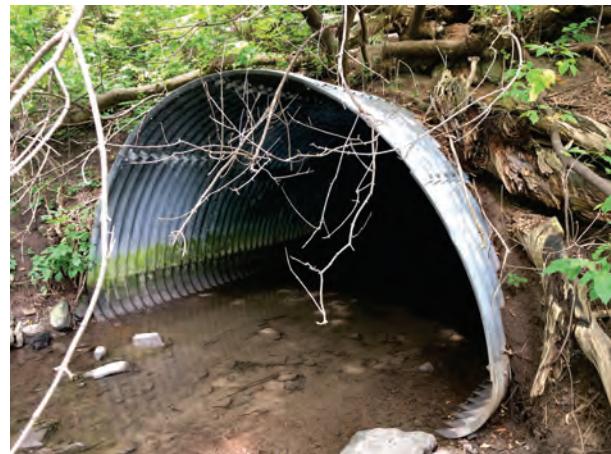
Photo 31: Culvert C6 (MTO Site 16X-0237/C0); Station 22+503 (Elizabethtown); Buells Creek, Highway 401 Eastbound, culvert outlet facing west (August 25, 2020)

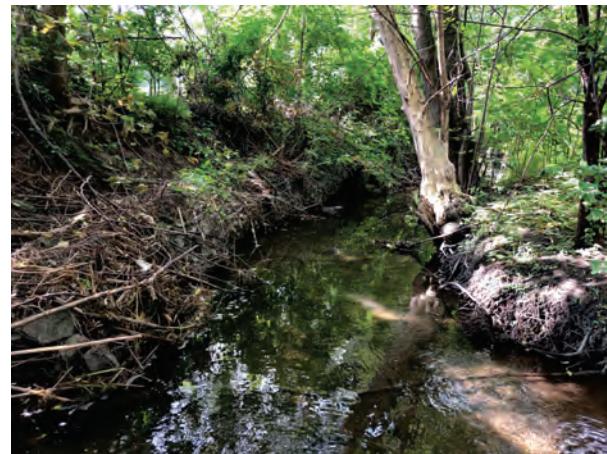
Photo 32: Culvert C6 (MTO Site 16X-0237/C0); Station 22+503 (Elizabethtown); Buells Creek, Highway 401 Eastbound, facing southeast (downstream) (August 25, 2020)

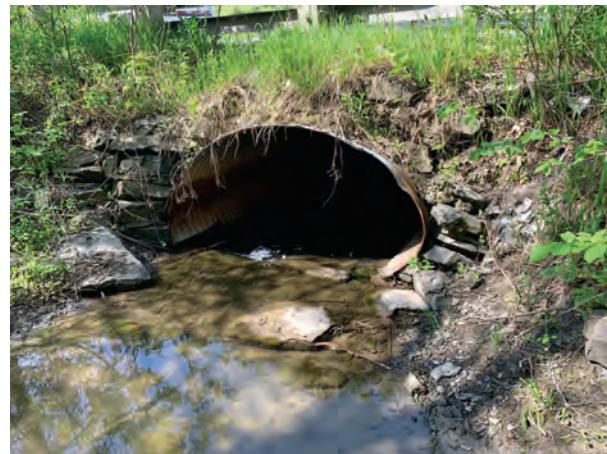
Photo 37: Ormond Street; Tributary to Buells Creek, Ormond Street, Northbound, facing west (downstream) (May 18, 2021)

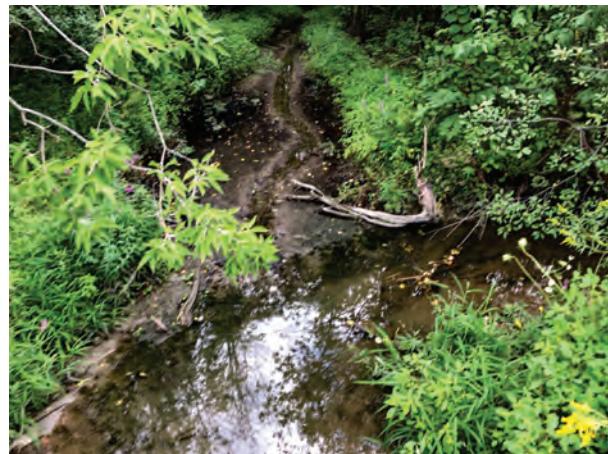
Photo 38: Ormond Street; Tributary to Buells Creek, Ormond Street, Northbound, facing east (upstream) (August 25, 2020)

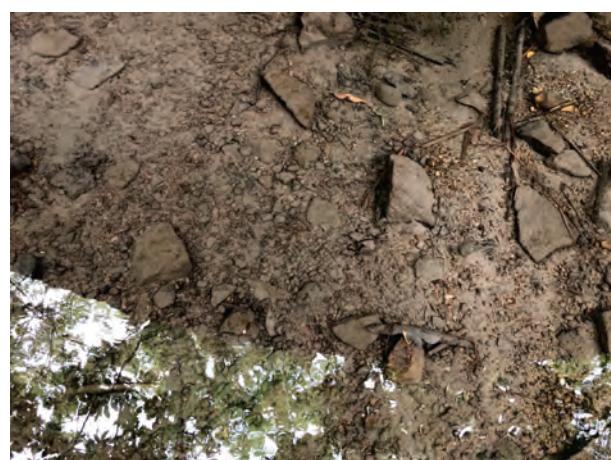
Photo 33: Culvert C6 (MTO Site 16X-0237/C0); Station 22+503 (Elizabethtown); Buells Creek, Highway 401 Eastbound, facing the streambed (August 25, 2020)

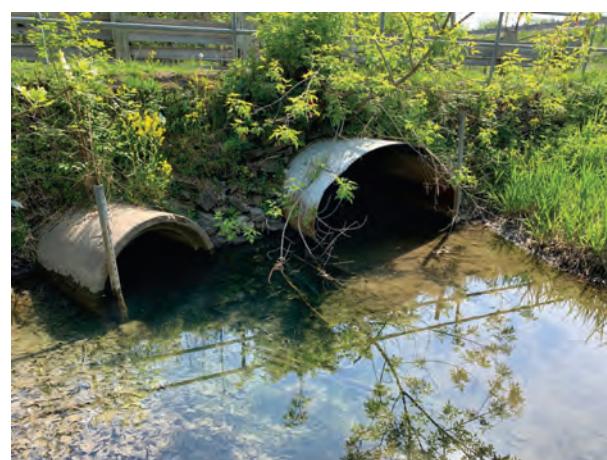
Photo 34: Ormond Street; Tributary to Buells Creek, Ormond Street Southbound, facing east (upstream) (May 18, 2021)

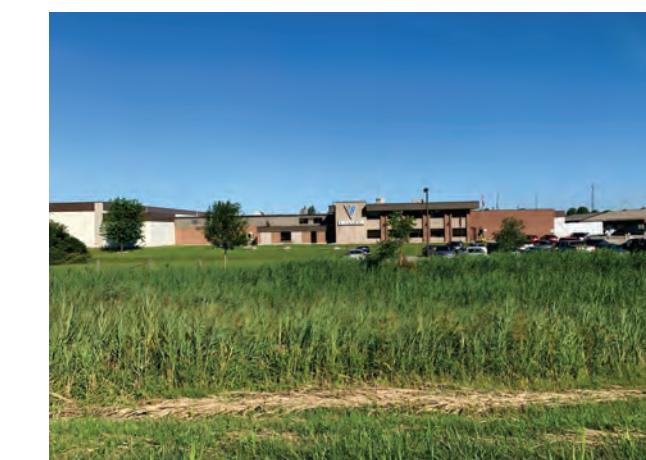
Photo 39: Culvert C7; Station 22+796 (Elizabethtown); Highway 401 Westbound, facing northwest (August 25, 2020)

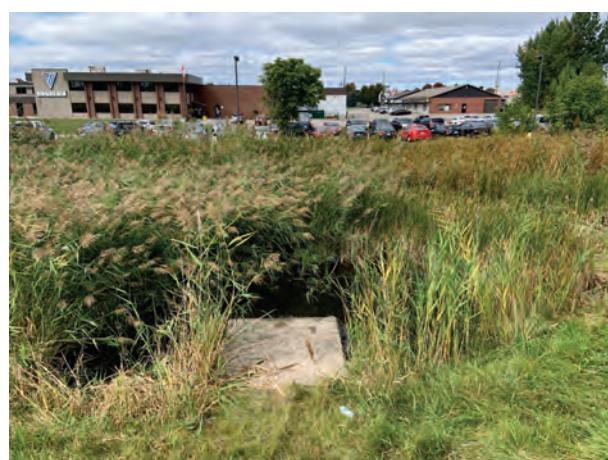
Photo 40: Culvert C7; Station 22+796 (Elizabethtown); Highway 401 Westbound, facing northwest (downstream) (August 25, 2020)

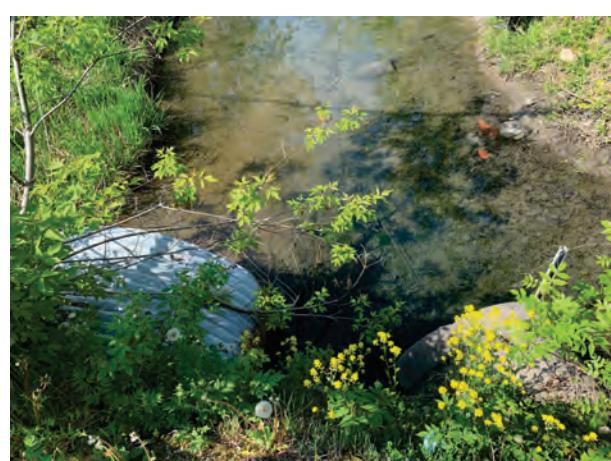
Photo 35: Ormond Street; Tributary to Buells Creek, Ormond Street, Southbound, facing west (downstream) (May 18, 2021)

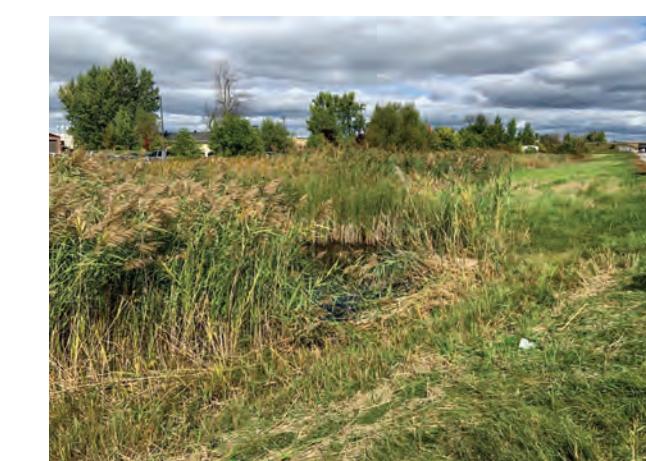
Photo 41: Culvert C7; Station 22+796 (Elizabethtown); Highway 401 Westbound, culvert outlet facing north (August 25, 2020)

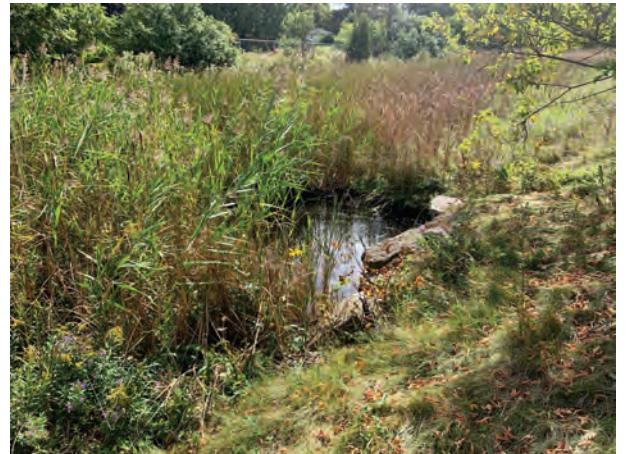
Photo 43: Culvert C7; Station 22+796 (Elizabethtown); Highway 401 East-bound, facing southwest (upstream) (August 25, 2020)

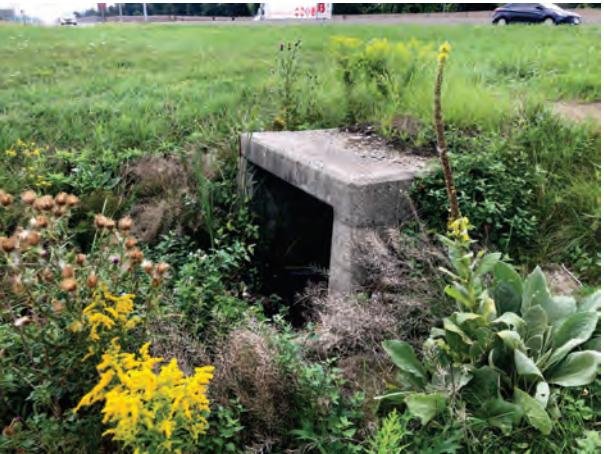
Photo 44: Culvert C8; Station 23+400 (Elizabethtown); Highway 401 West-bound, facing southeast (north end of culvert) (August 25, 2020)

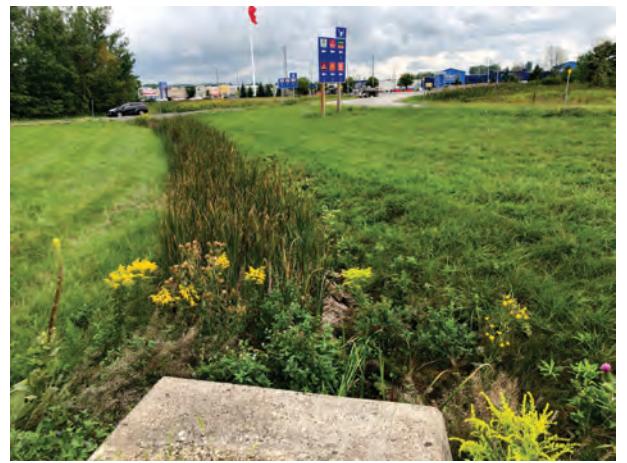
Photo 45: Culvert C8; Station 23+400 (Elizabethtown); Highway 401 West-bound, facing northwest from culvert (August 25, 2020)

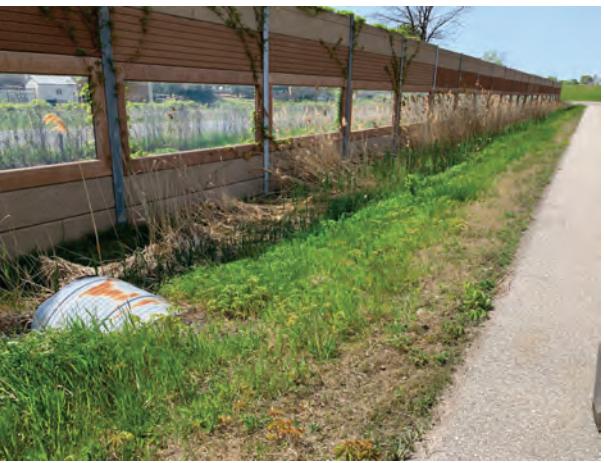
Photo 46: Culvert C8; Station 23+400 (Elizabethtown); Highway 401 East-bound on-ramp, south side of ramp, facing west (May 18, 2021)

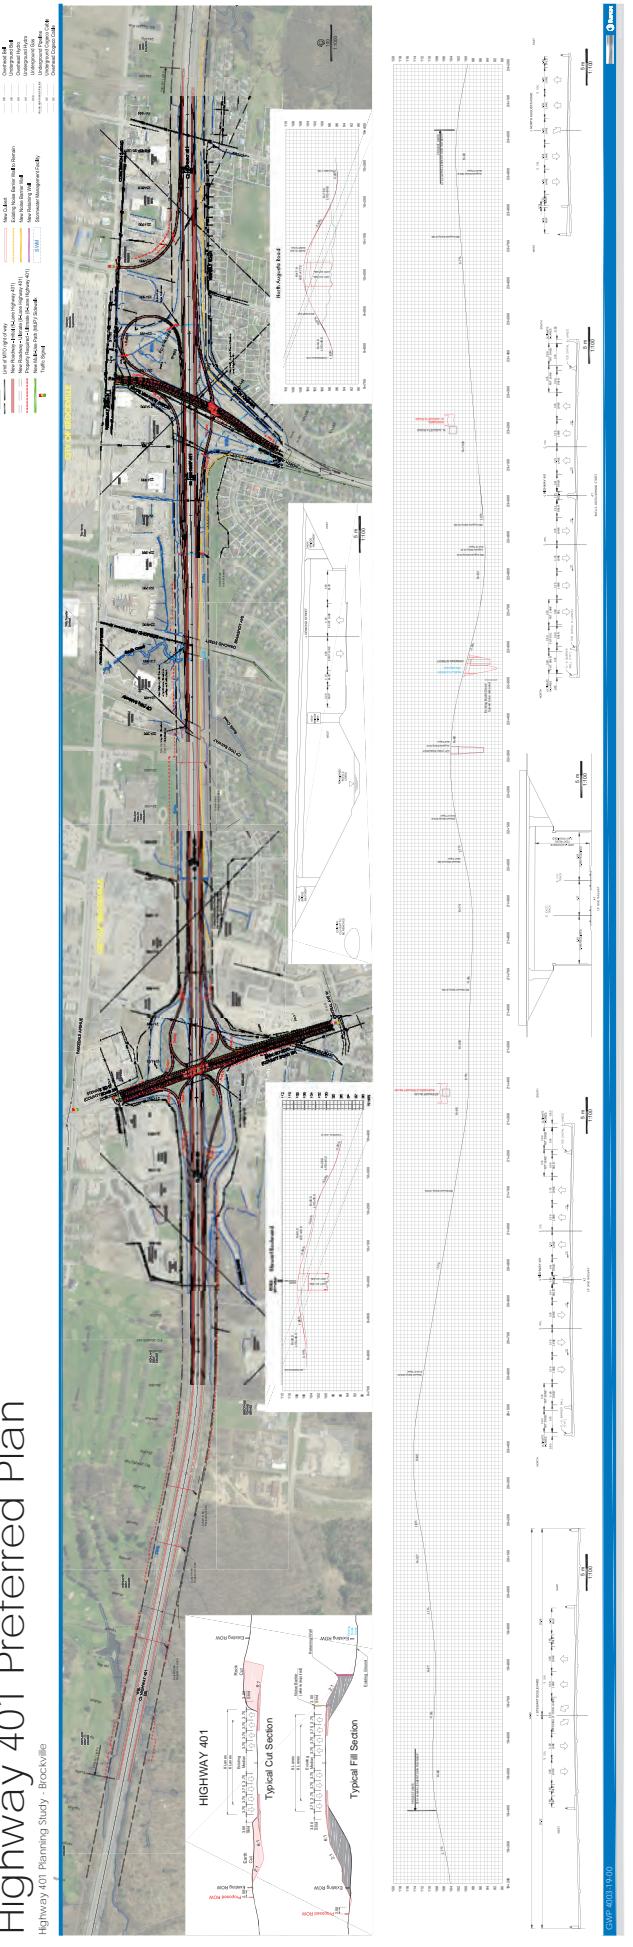
Highway 401 Preferred Plan

The Recommended Plan for the Study Area (**Appendix E**) includes the following activities that have the potential to affect fish and fish habitat:

- Expansion of Highway 401 to an interim 6-lane and ultimate 8-lane cross-section
- Improvements to the management of stormwater (e.g., ditching)
- Culvert improvements (replace or line) (see **Table 5, Appendix C**)
- The Buells Creek culvert (Culvert C6, Site 16X-0237/C0) beneath Highway 401 will be removed
- Buells Creek will be realigned closer to (i.e., toward) Ormond Street
- The existing Ormond Street structure (i.e., the Highway 401 overpass over Ormond Street) will be removed and replaced with a new structure that will span both Buells Creek and Ormond Street. The bridge will be designed to accommodate the ultimate 8-lane Highway 401 cross-section
